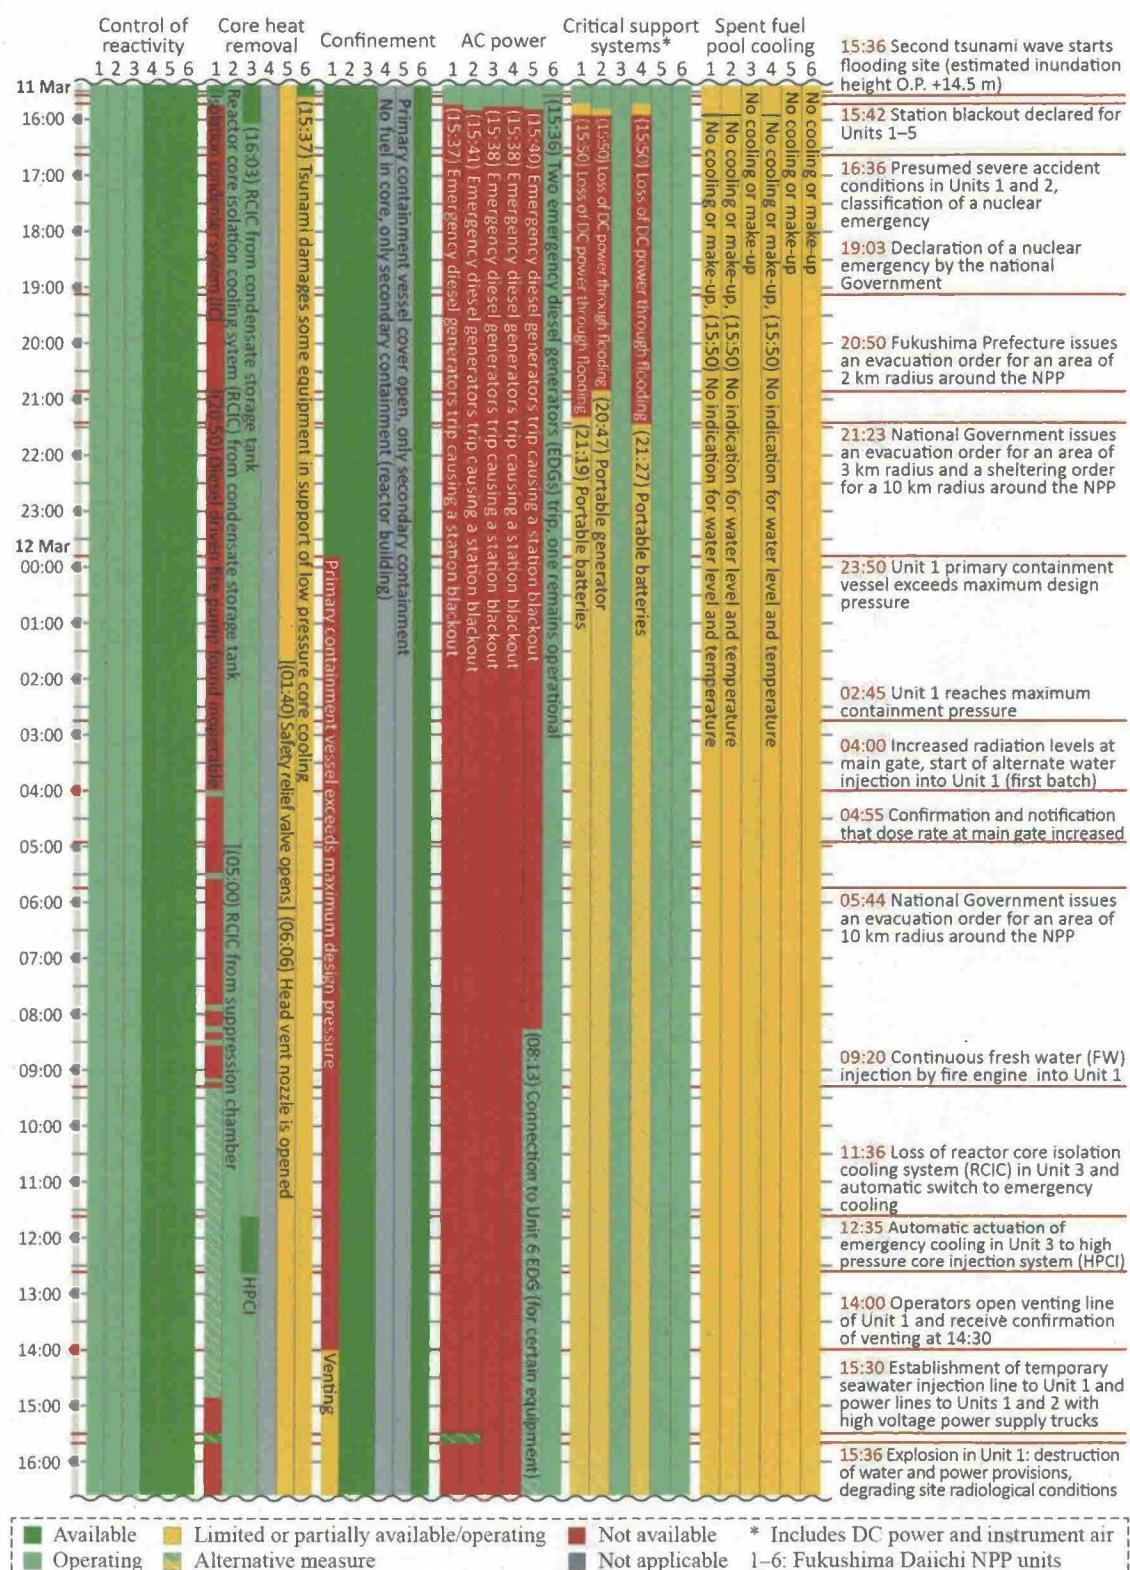
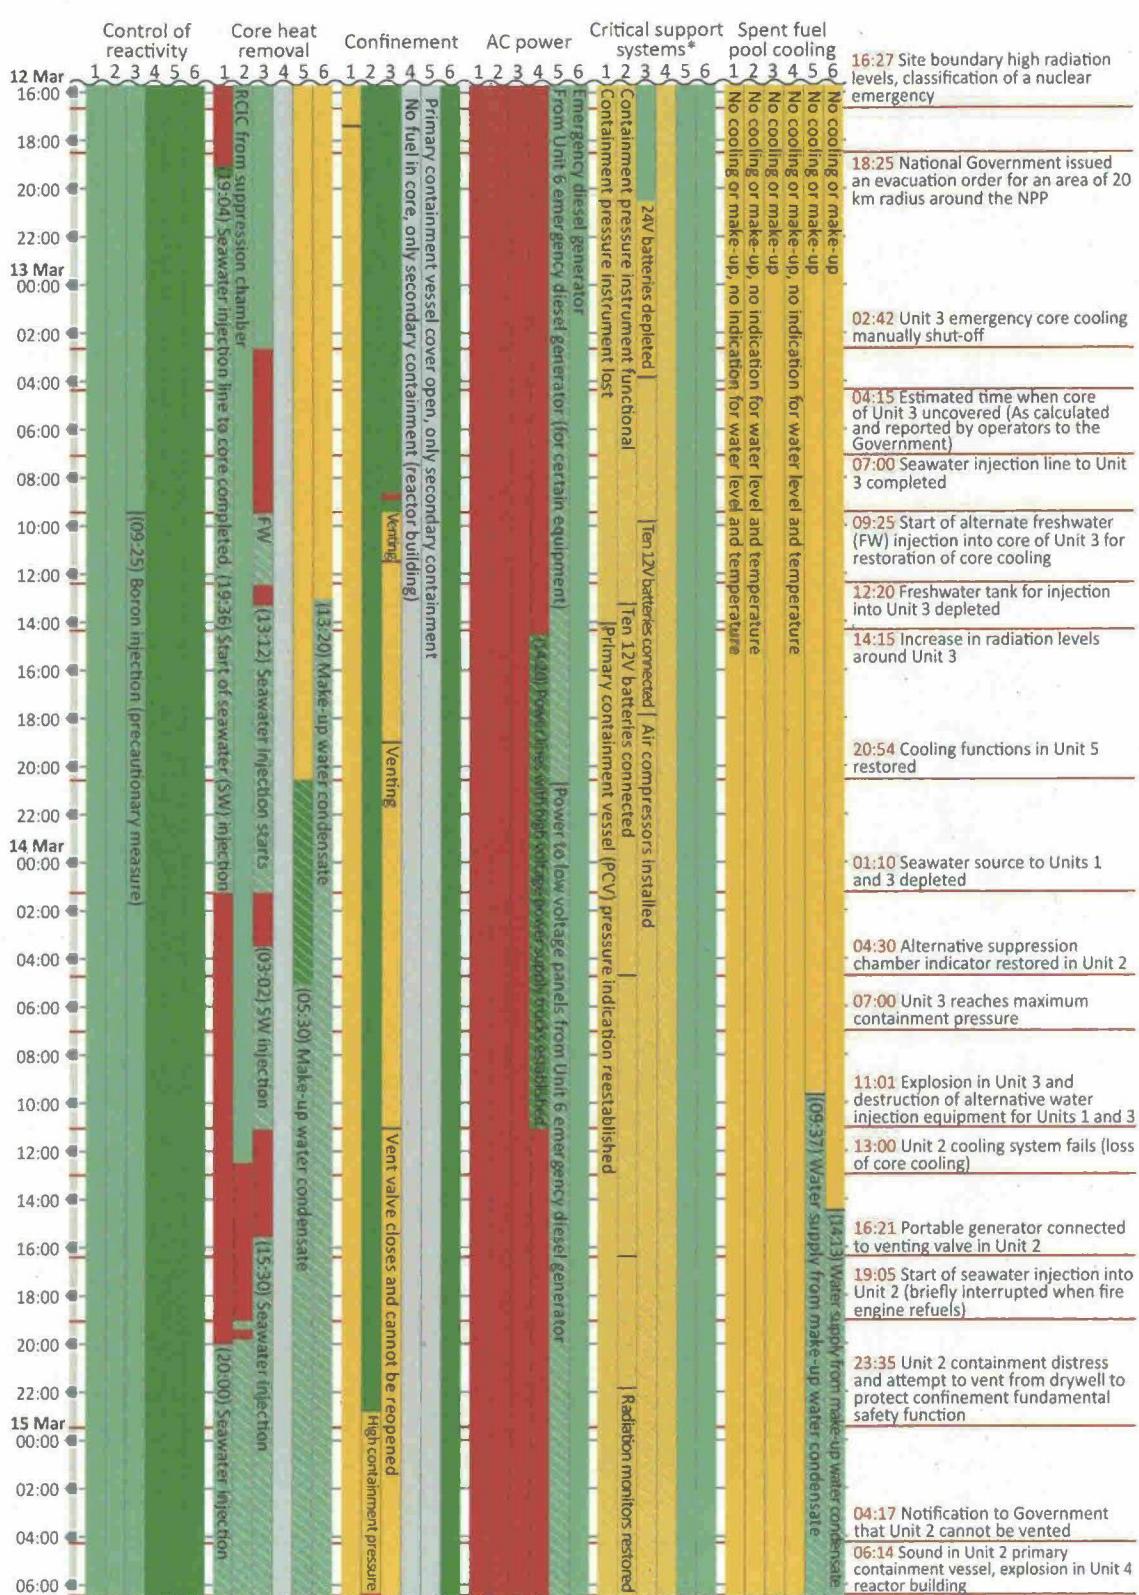
During this sequence of events, fundamental safety functions of Units 1–3 were lost or severely degraded (Fig. 2.5), and efforts focused on damage assessment and restoration and stabilization of those functions.

FIG 2.5. Fundamental and supporting safety functions in the accident response at the Fukushima Daiichi NPP (11–15 March 2011).

FIG 2.5(cont.). Fundamental and supporting safety functions in the accident response at the Fukushima Daiichi NPP (11–15 March 2011).

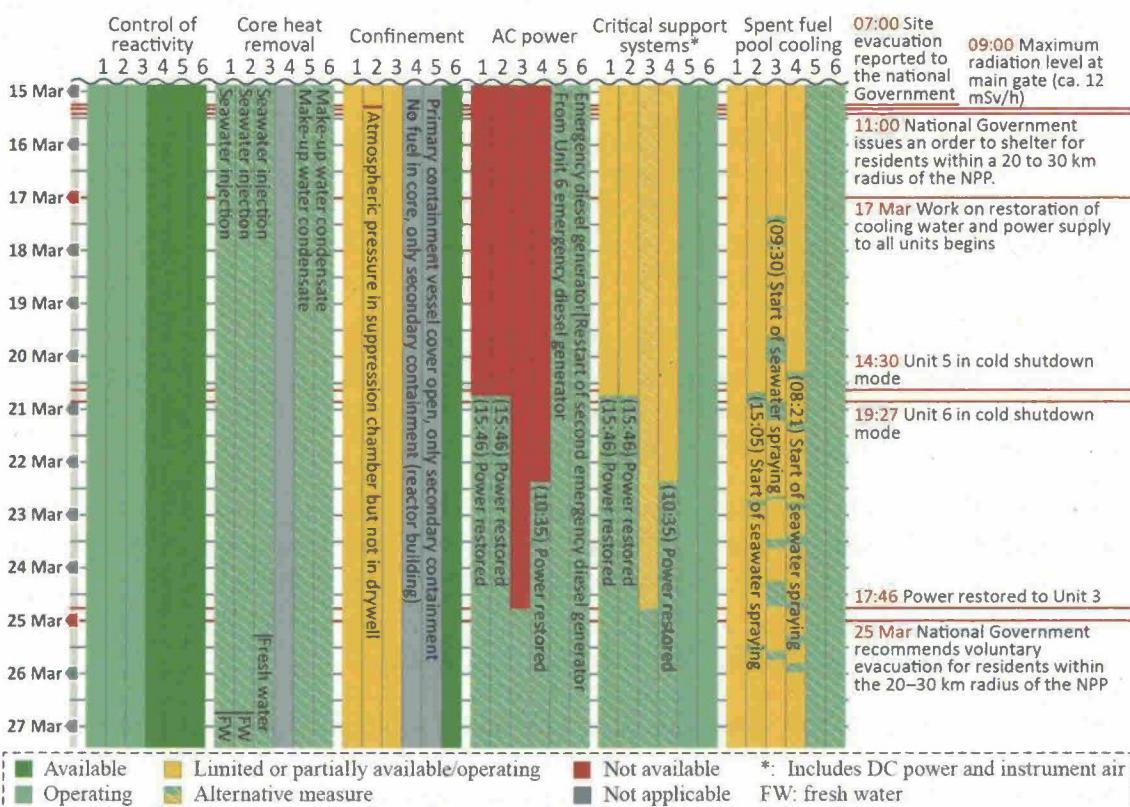
The normal residual heat removal system of Unit 6 was put back in service, in a manner similar to that at Unit 5, at 18:48 on the same day. The reactor temperature decreased below 100°C in less than one hour, placing Unit 6 in the cold shutdown mode at 19:27 on 20 March (Fig. 2.6).

FIG 2.6. Temporary restoration of fundamental safety functions at the Fukushima Daiichi NPP.

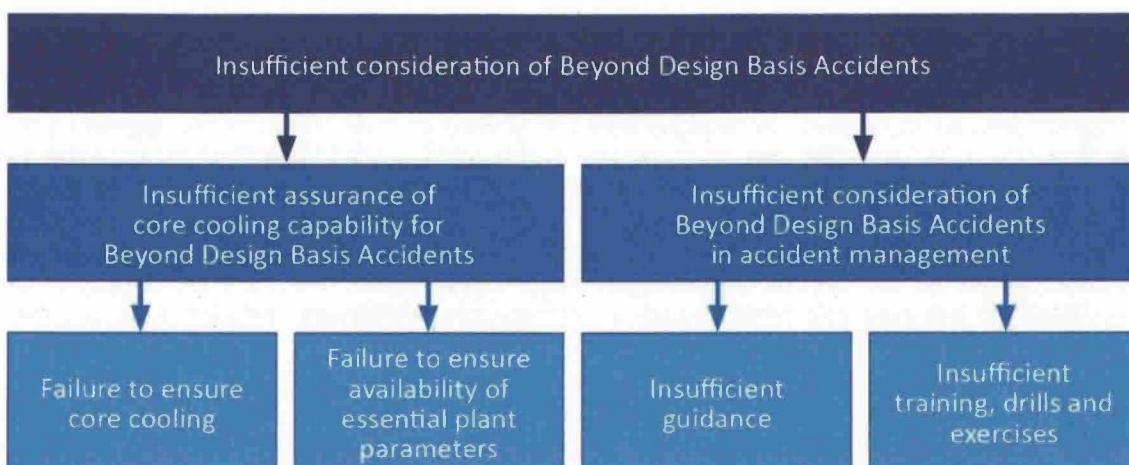
The Fukushima Daiichi NPP had some weaknesses which were not fully evaluated by a probabilistic safety assessment, as recommended by the IAEA safety standards [49, 51]. Examples include the lack of protection for the emergency diesel generators, battery rooms and switchgear against flooding and the low likelihood of success of severe accident interventions, given the limited guidance, training and knowledge of plant personnel for severe accident management. Beyond design basis accidents were not sufficiently considered, which affected the capability to maintain cooling of the reactor core, the operators' ability to monitor important safety parameters and the management of the severe accident conditions (See Fig. 2.7).

FIG 2.7. Impact of the insufficient considerations of beyond design basis accidents affected the capability to maintain cooling of the reactor core, the operators' ability to monitor important safety parameters and the management of the severe accident conditions [27, 52].
