**Analysis of Russian Military Activity at the
Zaporizhzhia Nuclear Power plant (ZNPP)
During June & August 2025**

December 2025

Proprietary:
Forbes McKenzie
McKenzie Intelligence Services
forbes@mckenzieintelligence.com
Commissioned by Greenpeace Ukraine

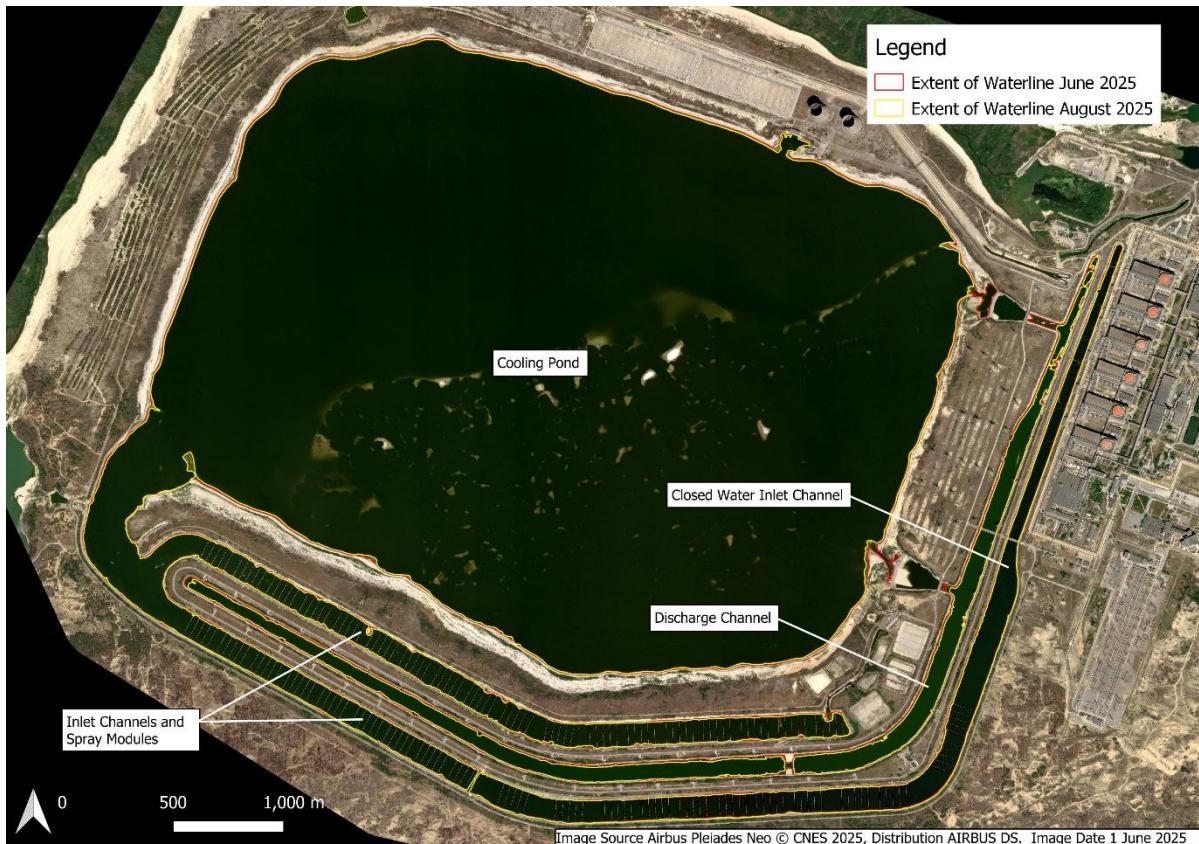
Fig.2 – Illustration of Receding Water Levels over Reporting Period

A noticeable reduction in the volume of water contained in the cooling pond and channels was evident after reviewing both images. While it is not possible to calculate volume from the imagery, an analysis was conducted to determine the total surface area of the water in the pond, canals and closed cooling canal. The results of the analysis are listed at Table 1 below and illustrated at Fig.2.

Image Date	Cooling Pond and Channels	Discharge Channel
03 July 2022 (pre destruction of Kakhovka Dam)	9,599,617m ²	Not Measured
1 June 2025	8,767,820m ²	429,157m ²
12 August 2025	8,662,141m ²	365,360m ²
Reduction	105,679m ²	63,797m ²

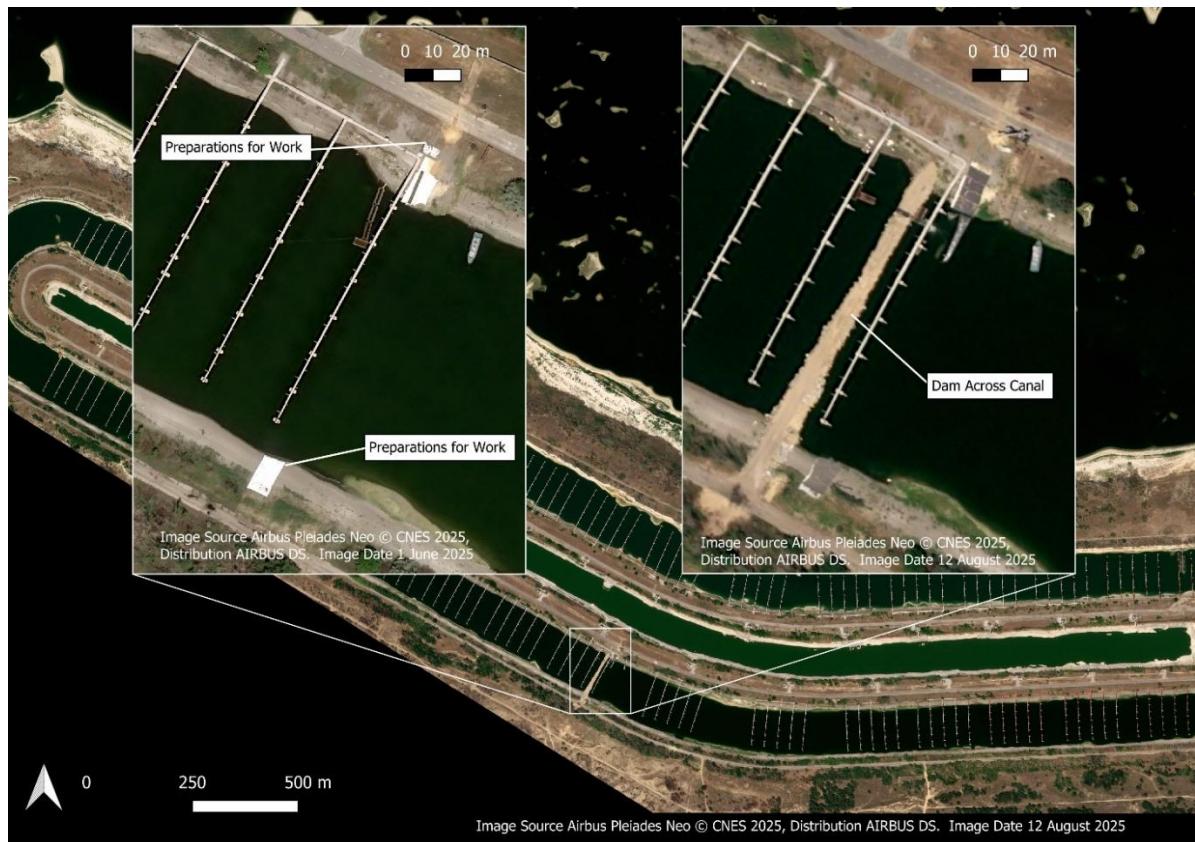
Fig.3 – Construction of Dam Within Intake Channel

Within the intake channel and amongst the spray jet modules, construction of a small dam was identified, effectively creating a smaller closed channel Fig.3. The dam was not present in the June imagery although the start of work or preparations for the construction were observed. By 12 August, the dam was present and construction continued. By 15 October a further pontoon or boom had been positioned adjacent to the recently constructed dam (Fig.4). This object has the appearance of being inflatable suggesting it is floating on the water but attached to each bank on the plant side of the inlet channel. A series of cables or pipes are evident both on the pontoon/boom and on the recently constructed dam. The exact purpose of the boom/pontoon cannot be determined from the imagery. It is highly unlikely that it has been placed as a crossing for either vehicles or personnel; there are no approaches on the southern bank to suggest this is a crossing nor is it considered that the boom/pontoon would provide the support or stability for this purpose. There is no visible turbulence in the water on the boom side of the dam so it is unlikely that water was being pumped from the pond side to the plant of the dam at the time of image collection. There is a highly noticeable variation in the colour of water on either side of the dam with a light green hue visible on the pond side of the dam. This suggests a bloom of algae is present on the pond side of the dam. This algae bloom is also visible in the wider cooling pond and within the discharge channel. The plant side of the dam displays a darker return to the water.

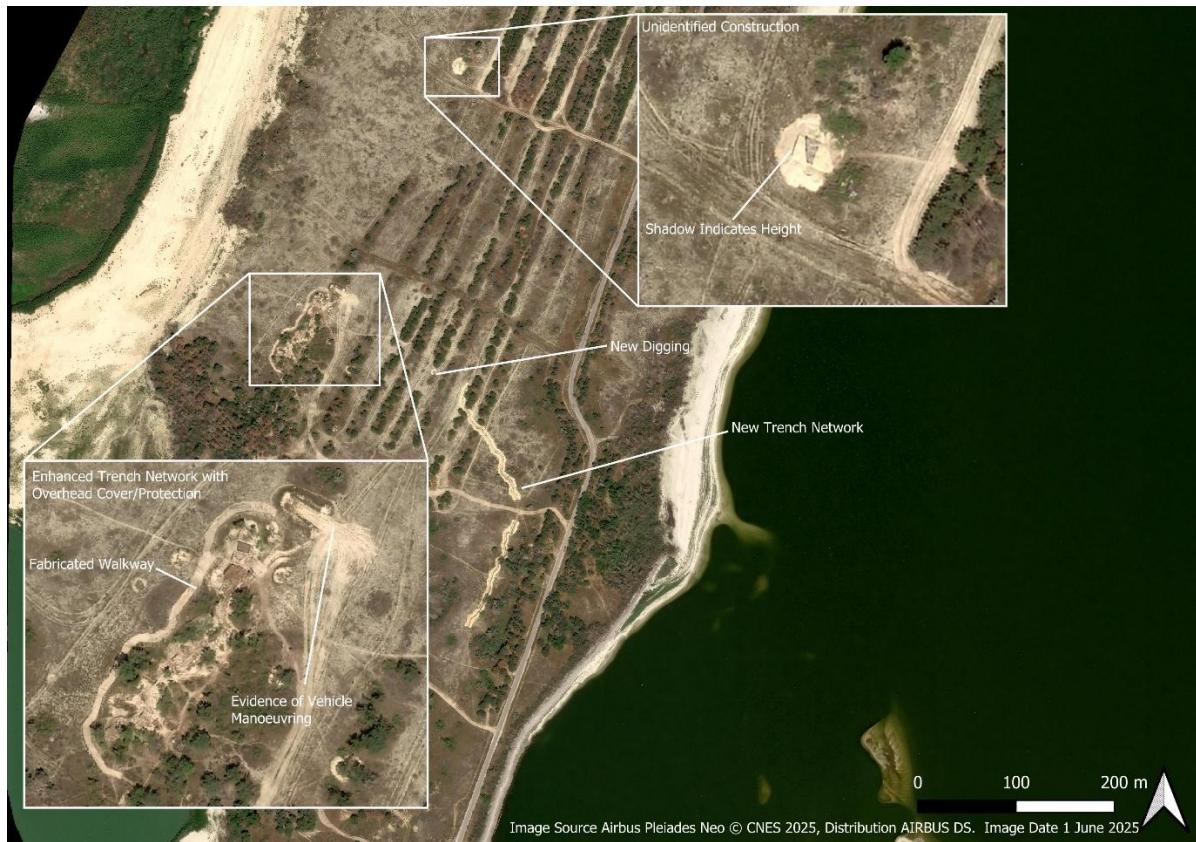
Fig.6 – Enhancement to Trenches in Vicinity of Sluice Gate

As with other areas around the cooling pond, there has been some clearing of vegetation and new trench construction and other digging (Fig.6). Pre-existing trenches have had some enhancement such as extending the overall extent of the trenches or adding overhead cover or protection. Other enhancements include the adding of a cleared and levelled strip of ground in front of the trench network. It is not clear what purpose this cleared and levelled strip serves; it does not follow any clear military logic or purpose. Vehicle tracks indicating

movement of vehicles was also evident in the area. At the northernmost point of this area, a new construction is underway. It is not clear what this construction is but appears to be dug in with some form of overhead cover, possible an observation post.

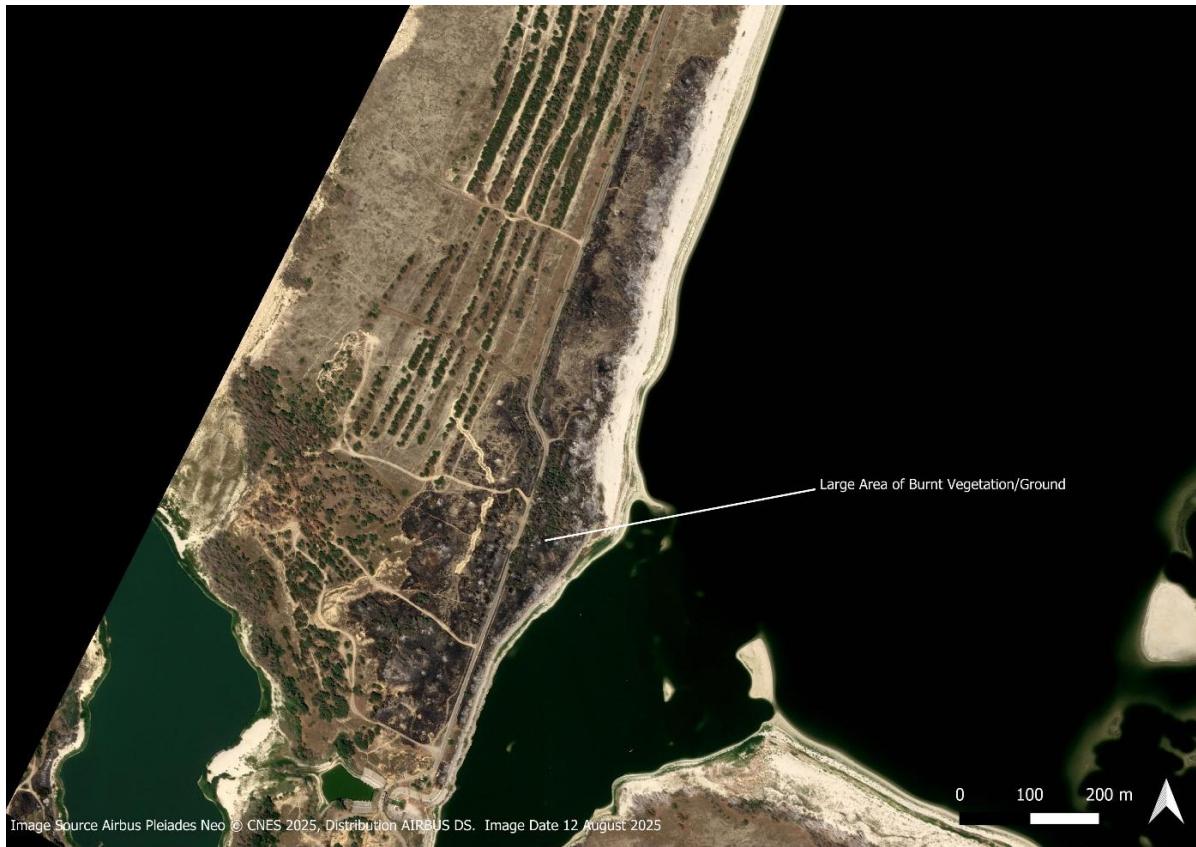
Fig.7 – Area of Burnt Ground and Vegetation

At some point between 01 June and 12 August 2025, a substantial fire has occurred, indicated by a large area of burnt vegetation. It cannot be determined what caused the fire or if it was started deliberately (Fig.7).

Analyst Comment: Open source reporting ([ua-energy.org dated 21 July 2025 <https://ua-energy.org/en/posts/21-07-2025>](https://ua-energy.org/en/posts/21-07-2025)) stated that a forest fire occurred nearby to ZNPP but that at no time was there any danger to the plant. **Comment Ends.**

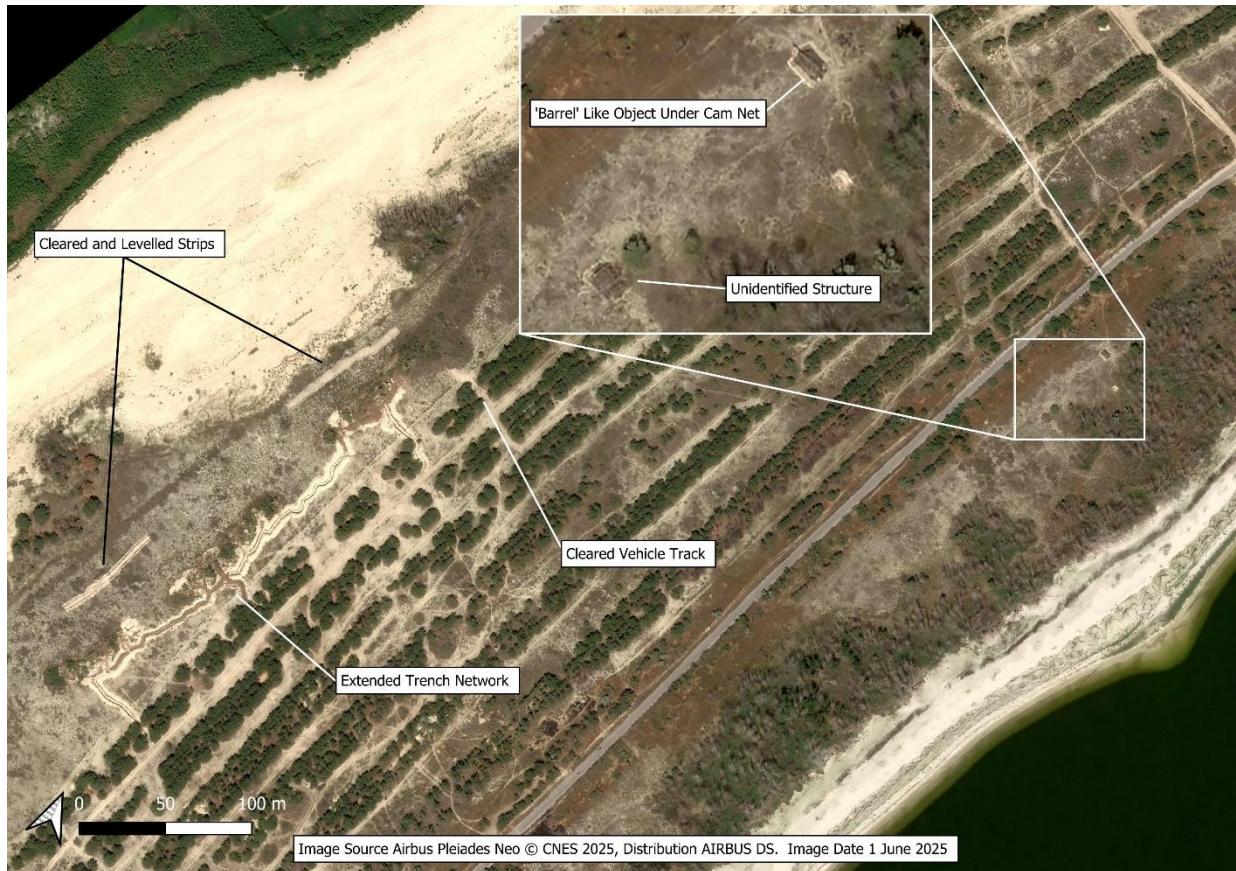
Fig.8 – Enhancement to Trench Network on Western Bank

The previously identified trench network, consisting of fighting and communication trenches, in this area of the cooling pond banks has undergone significant development (Fig.8). The fighting trenches have been extended to link the existing trenches together to form a single larger trench. The trench construction follows doctrinal norms in that they follow a zig-zag design; a widely used defensive design for trench warfare. Two cleared and levelled strips have been constructed to the front of the trenches. As with the previous area, the purpose of these strips is unclear. A vehicle track has been cleared to the immediate north of the position. Closer to the cooling pond in this area of the western bank, there are two positions of interest. The first is an unidentified structure, possible with overhead cover or protection or covered by camouflage netting (Cam Net). The second position is also unidentified and displays what could be a 'barrel' like object or some form of ridge under a Cam Net or similar. It is considered highly unlikely that this is a piece of military hardware.

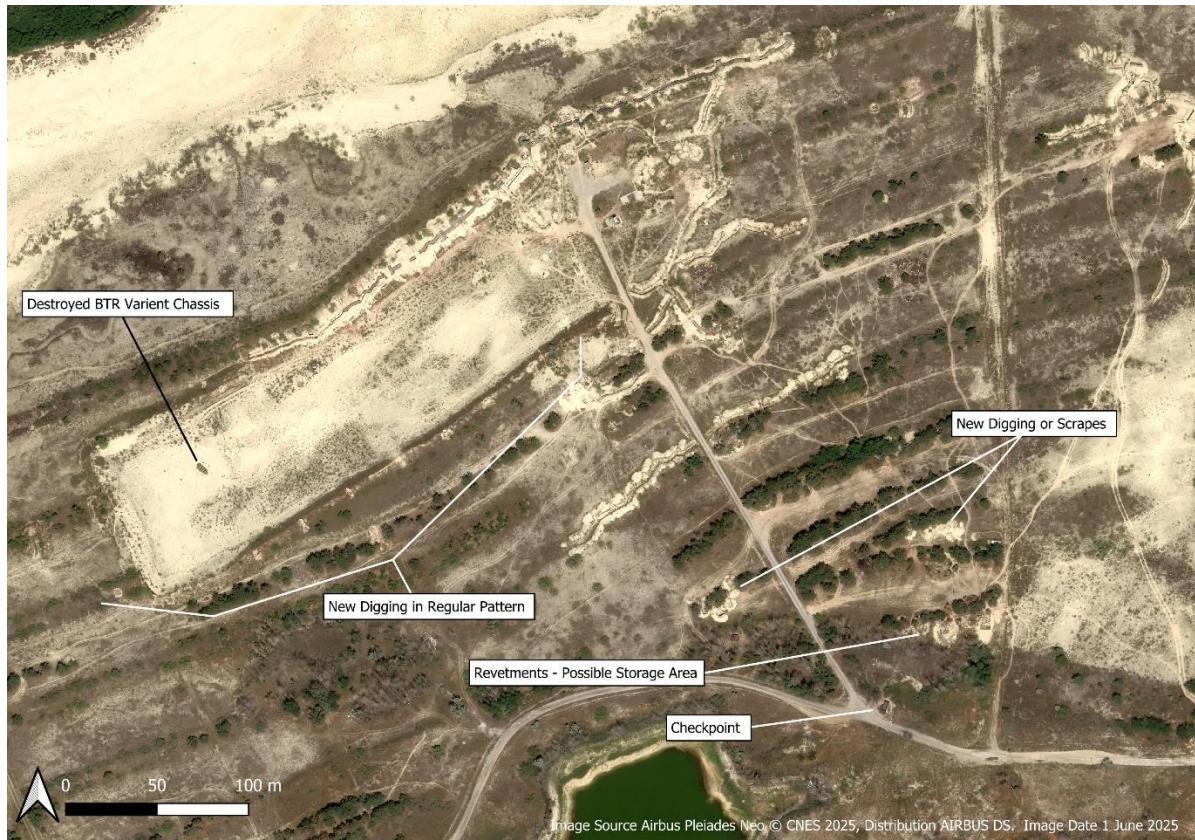
Fig.9 – Military Positions on the Northwestern Bank

The northwestern area of the cooling pond banks displays a considerable militarisation of the ground (Fig.9). Pre-existing trenches constructed since the Russian occupation remain and do not appear to have been increased. However, there are other changes which are significant. A series of small scrapes or berms have been dug in regular succession along the large open area. The appearance of these scrapes suggests they are prepared positions for armoured vehicles to drive into. The previously identified vehicle positioned on the large clearing is displaying signs of debris strewn around it and vehicle hatches removed or open. The dimensions and appearance of this vehicle indicate the destroyed chassis of a BTR variant vehicle.

To the rear of this area, closer to the cooling pond there have been some new positions constructed. A checkpoint consisting of a barrier and adjacent guard post or position is located on the road running parallel to the pond. Nearby there are a number of revetments dug amongst some trees which appear to contain crates or other objects suggesting a storage area, possibly for ammunition. Slightly forward of these revetments two areas of digging or scrapes were also evident amongst the trees.

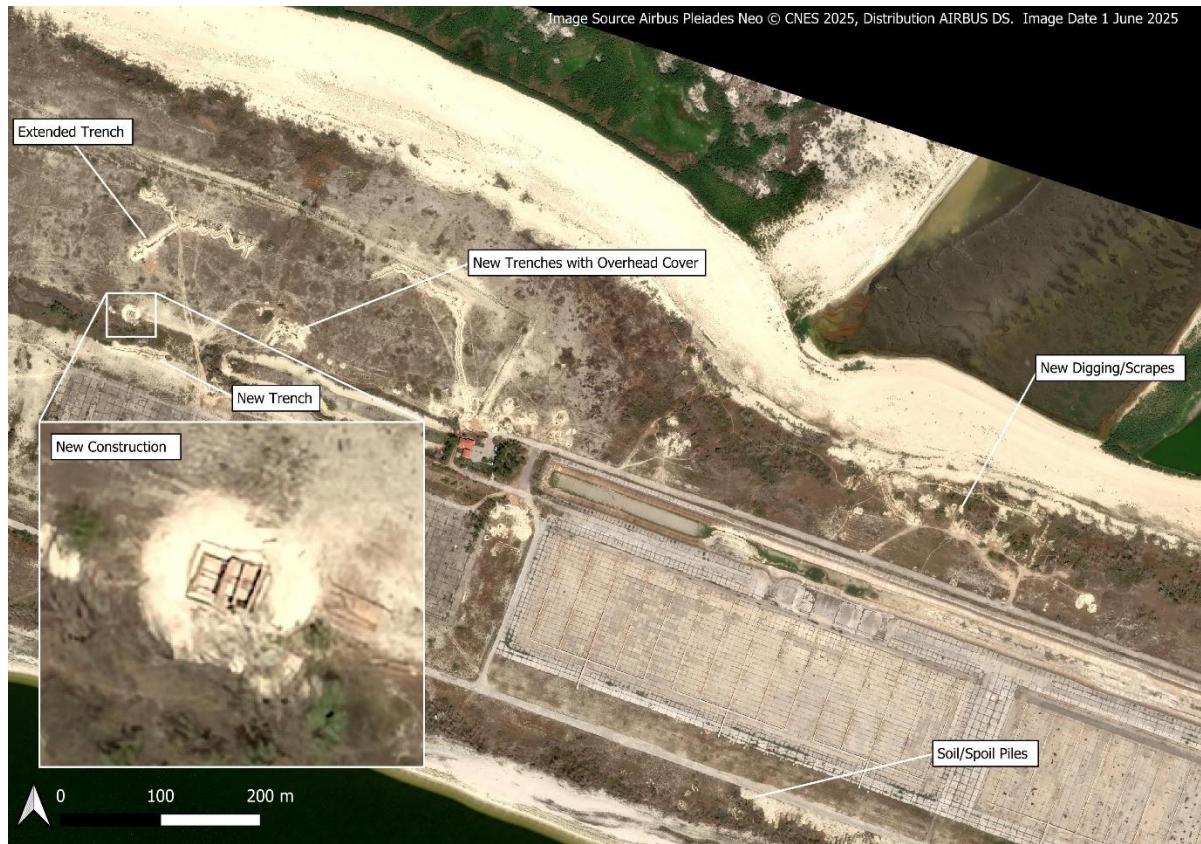
Fig. 10 – New Trenches and Construction in June 2025

01 June 2025 – The previously reported trench network in this area of the cooling pond had been and continued to be developed (Fig.10). New trenches and scrapes had been excavated and previously dug trenches had been extended. An area of construction was also underway adjacent to the new trenches. Shadow indicated significant depth to the construction and what appeared to be beams had been laid across the pit. The construction had been covered in soil in August suggesting some form of underground construction, by 15 October 2025, the construction had the appearance of a flat and solid structure or overhead cover suggesting a reinforced construction such as a bunker (Fig.11). This is similar in appearance to the structure identified previously near to the sluice gate on the western bank. Fresh digging was observed in other areas of the area. Piles of soil or spoil were being dumped along the rear of the cooling pond bank running parallel to the waterline. Previous MIS reporting on the activity at ZNPP highlighted the possibility of the construction of a pump house on the northern bank (MIS Update to the Analysis of the Russian Occupation in the Vicinity of the ZNPP Cooling Pond dated 5 December 2024 refers). Although there has been no further construction or excavation to suggest such a construction on 2025 imagery, there is nevertheless a concentration of Russian military activity including fortifications in this area of the cooling pond bank.

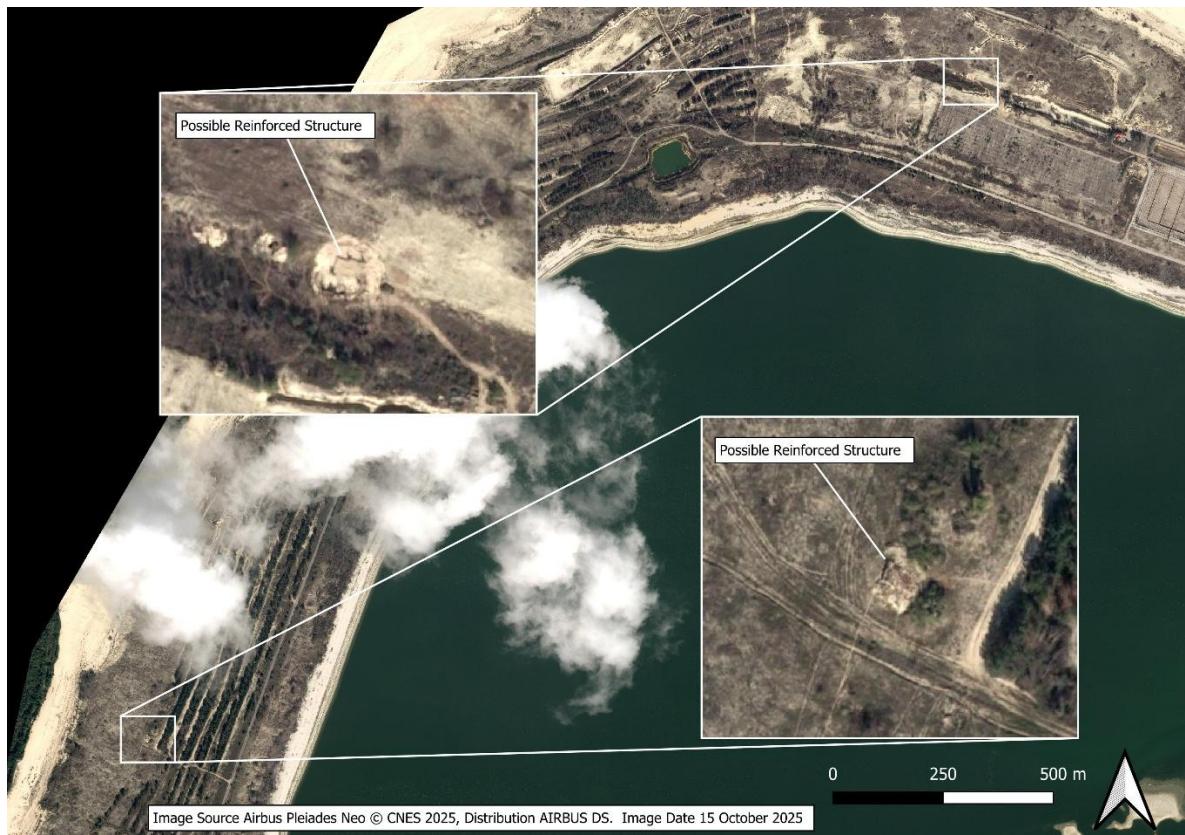
Fig. 11 – Possible Reinforced Structures

Analyst Comment: The reason for the construction of these 'bunkers' is unclear from imagery alone but it is of note that they have been placed at key locations around the cooling pond; by the sluice gate, on the western bank and on the northern bank. It is likely that they may represent a local command and control node over troops in that specific area. It does indicate the further militarisation of the area around the cooling pond. **Comment Ends.**

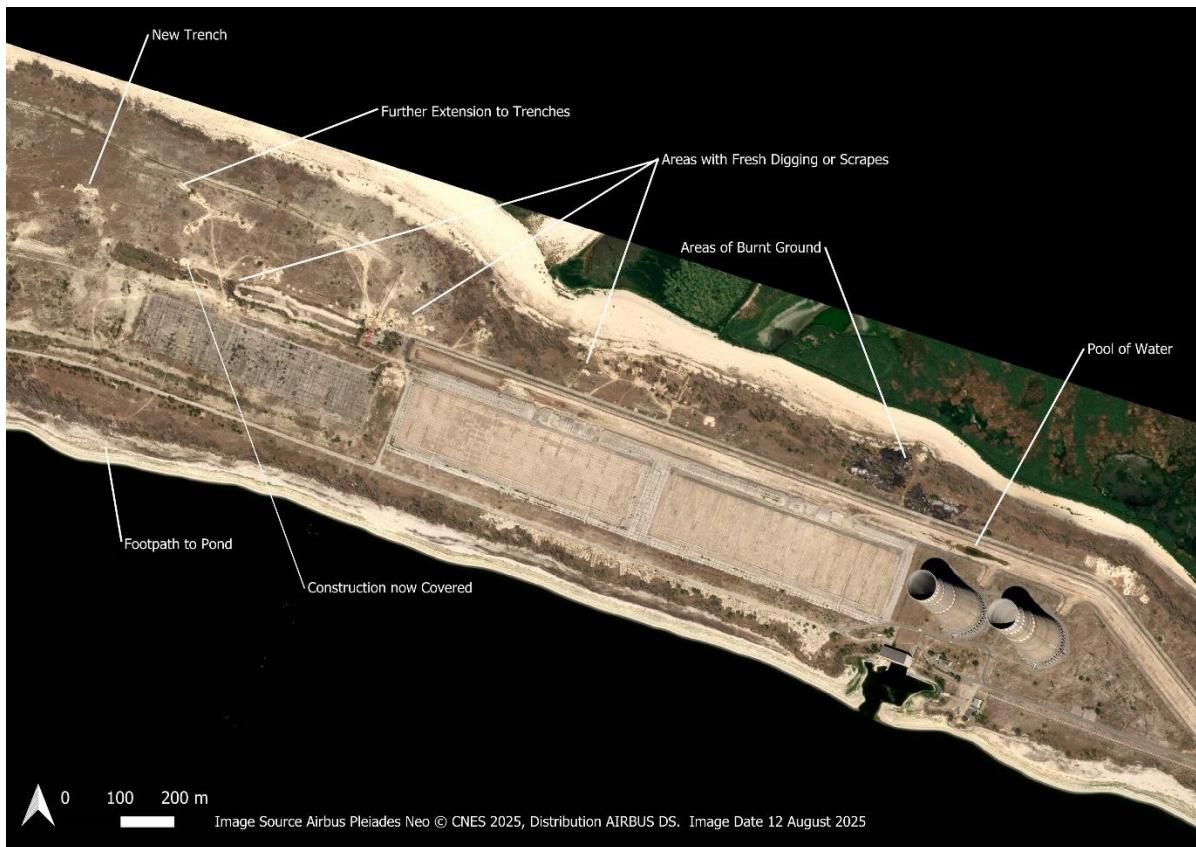
Fig. 12 – Area of the Northern Bank - August 2025

12 August 2025 – Work in this area of the cooling pond continued into August 2025 (Fig.12). New trenches had been dug and there was more work to extend existing trenches. The construction observed in June had now been covered over with soil and does not appear to be part of a trench system. The exact purpose of this construction remains unclear but is likely to have an underground element. A small footpath had developed leading to the water's edge of the cooling pond. This footpath appears to have become evident through repeated use rather than being constructed and may indicate a regular and frequent collection of water or disposal of waste. There continued to be small scale digging of scrapes in the vicinity of existing trenches and scrapes. To the east of this area there was evidence of a small fire with burnt ground observed close to the venturi cooling towers. A small pool of water was also evident in the adjacent channel while the remainder of the channel remains dry, potentially as a result of firefighting activities after the fire in the immediate vicinity.

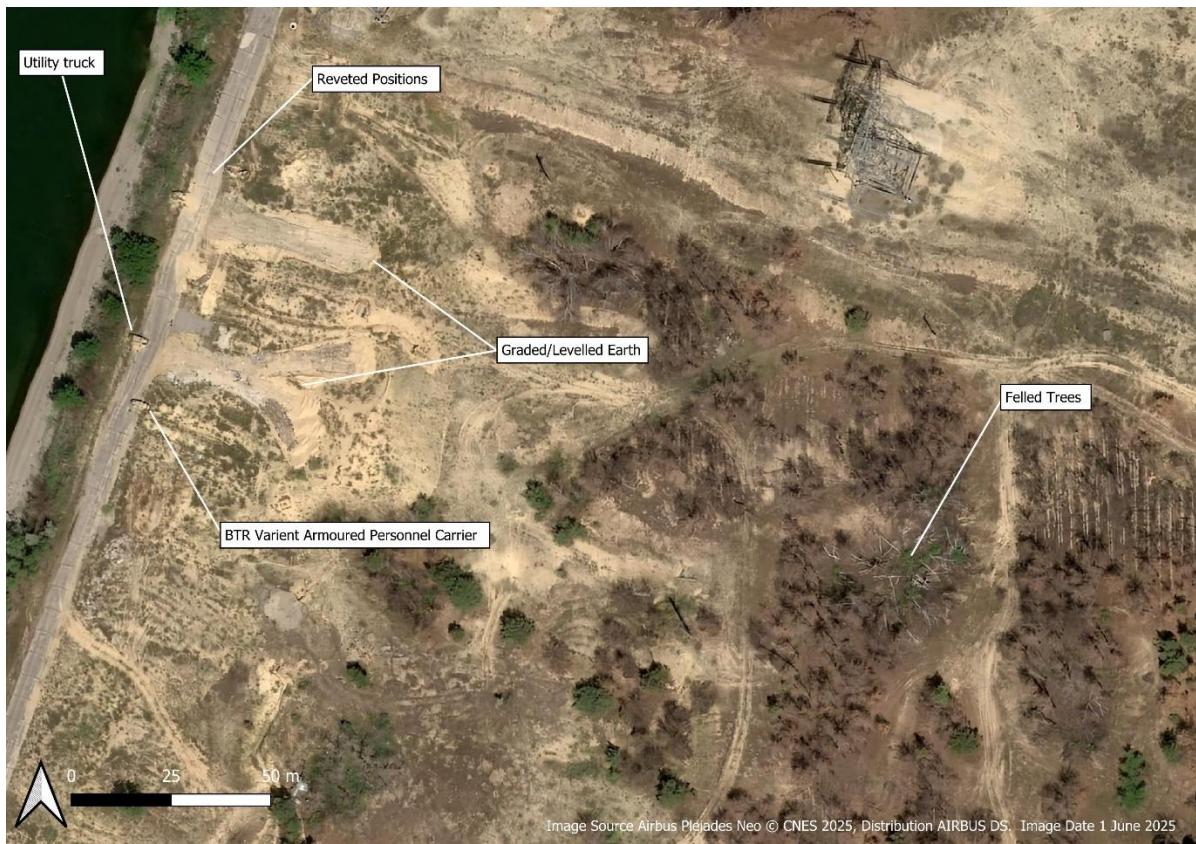
Fig. 13 – Checkpoint to the Southeast Area of Cooling Pond

A previously identified military checkpoint remained at the southeast area of the cooling pond and adjacent to the ZNPP associated transformer yard (Fig.13). The checkpoint consisted of a man-made chicane and was occupied by a BTR variant armoured personnel carrier and a utility truck. Two large graded or levelled areas of earth had been cleared in the immediate vicinity of the checkpoint. Also, two small revetments had been positioned either side of the road immediately to the north of the checkpoint. Further back and towards the transformer yard, an area of felled trees was evident. The checkpoint provides control of access to the area immediately south of the cooling pond.

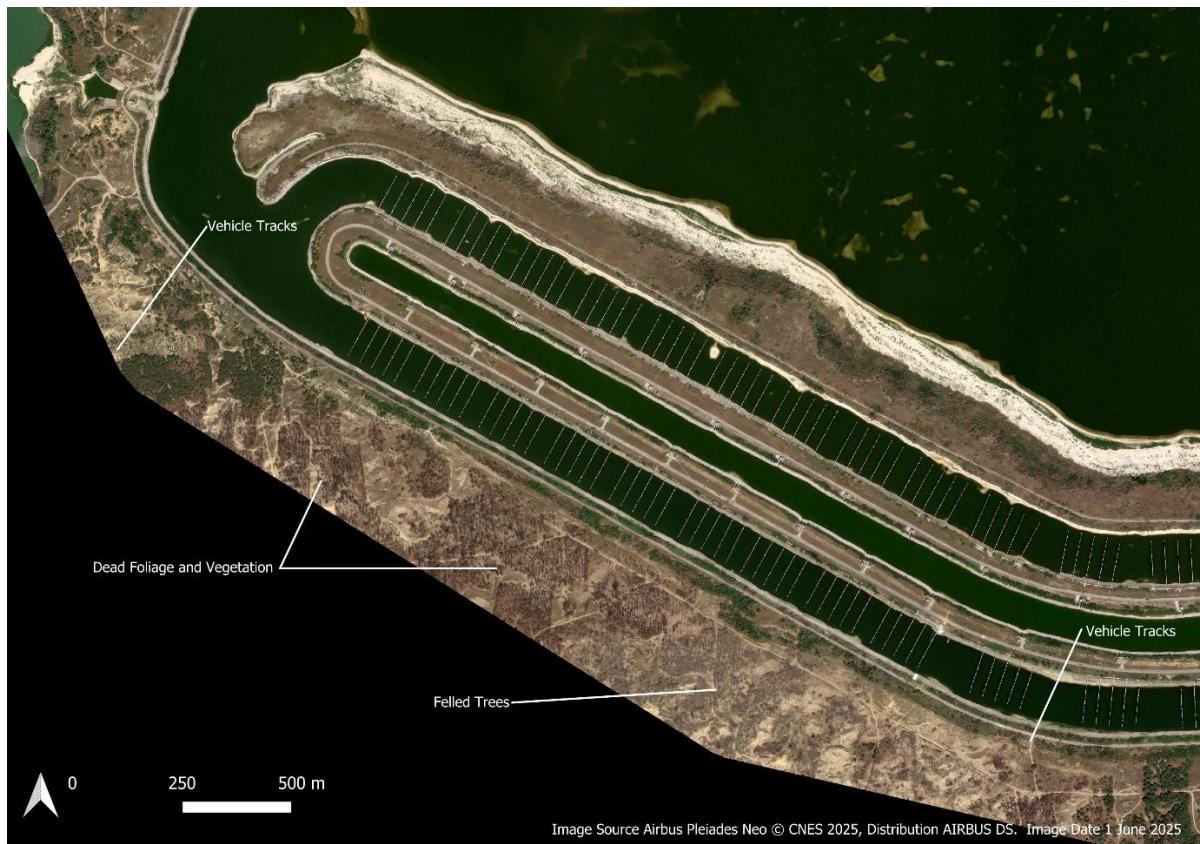
Fig. 14 – Dead Foliage and Felled Trees on Southern Bank

There was limited activity observed along the southern bank of the cooling ponds and the southern side of the cooling water channels (Fig.14). Despite some vehicle tracks evident on the southern bank, there was no obvious military activity observed. There was evidence of tree felling in some areas of the bank although there was no obvious explanation for the tree felling. There were also large areas where the vegetation appeared to be dead. Given the time of year, it would be expected that the trees and vegetation should be in leaf and displaying dense foliage. However much of the vegetation was displaying a brown colour with very sparse foliage.

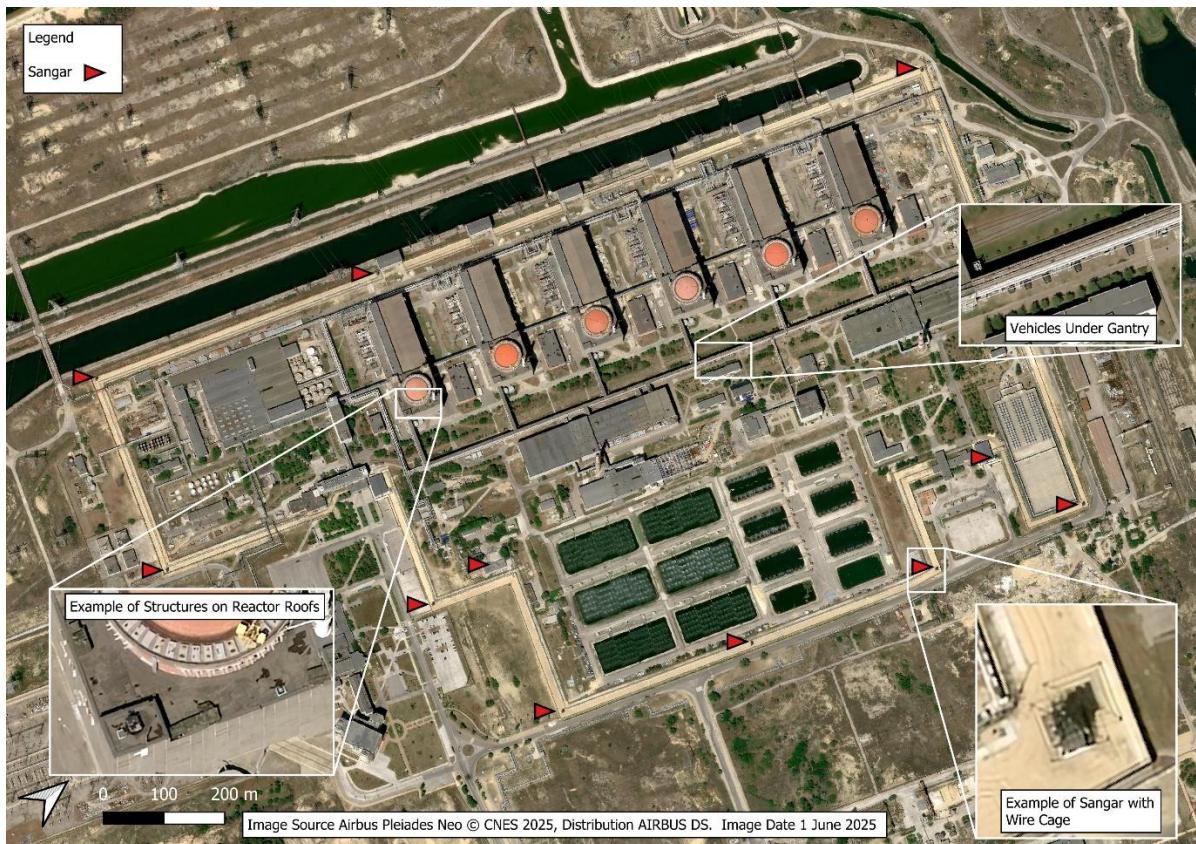
Fig. 15 – Further Militarisation of the Nuclear Power Plant

Analysis of the Nuclear Power Plant confirmed continued garrisoning of the installation. Some significant enhancements of the garrison included the construction of sangars at several points around the perimeter (Fig.15). The sangars appear to have a steel cage placed over or around them suggesting drone or projectile protection. A similar sangar was also observed on the roof of one of the buildings in the plant. The roof of the reactor buildings also had structures built on them, potentially sangars or observation posts. These structures did not appear to have the steel cages to protect them. The imagery also confirmed the continued practice of parking vehicles, including military vehicles under the raised gantries around the plant. Only minimal parts of the vehicles were evident, preventing a positive identification of vehicle types.

The introduction of the sangars around the nuclear power plant perimeter is a significant enhancement to the military posture at the installation. The sangars have an element of elevation and are protected by a steel mesh cage, usually associated with the protection against drone and projected warhead attack. These constructions are an aggressive measure commonly placed by military forces around their positions such as patrol bases and forward operating bases, particularly in environments with a high tempo of enemy activity. They are not a physical security barrier such as a fence or wall but are designed to position troops to observe the area external to the location and to have interlocking arcs of fire. In this instance, it is highly likely that the addition of these aggressive security structures is feeding the Russian narrative that ZNPP is under threat whereas in reality, no threat exists. Ukraine is almost certainly not going to conduct any operations that will compromise nuclear safety at ZNPP. Although it cannot be determined from imagery, it is highly likely that these positions will be manned by troops equipped with small arms and likely up to larger heavy machine guns.

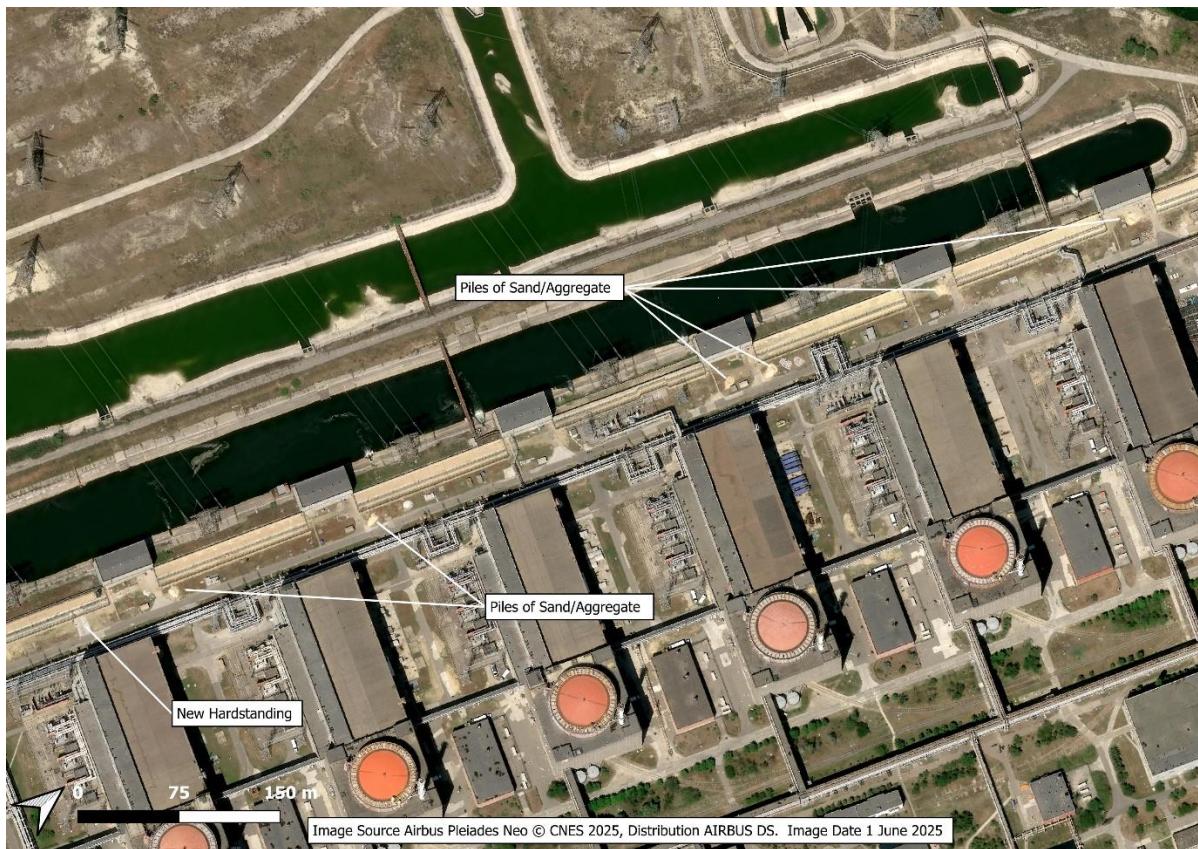
Fig. 16 – Evidence of Construction Work at Nuclear Power Plant

At the rear of the reactor and turbine halls, there appeared to be some undetermined construction work ongoing. A new hardstanding had been built and there were some piles of sand or aggregate observed (Fig.16). The spent fuel storage area had undergone some changes (Fig.17). A wire mesh has been constructed over the dry cask containers of spent fuel, claimed by ROSATOM as protection against UAV. In addition, an internal wall or barrier had been constructed within the spent fuel compound.

While it is clear that there is some small-scale construction work ongoing at the plant, it could not be determined from imagery what the construction work entailed or its purpose.

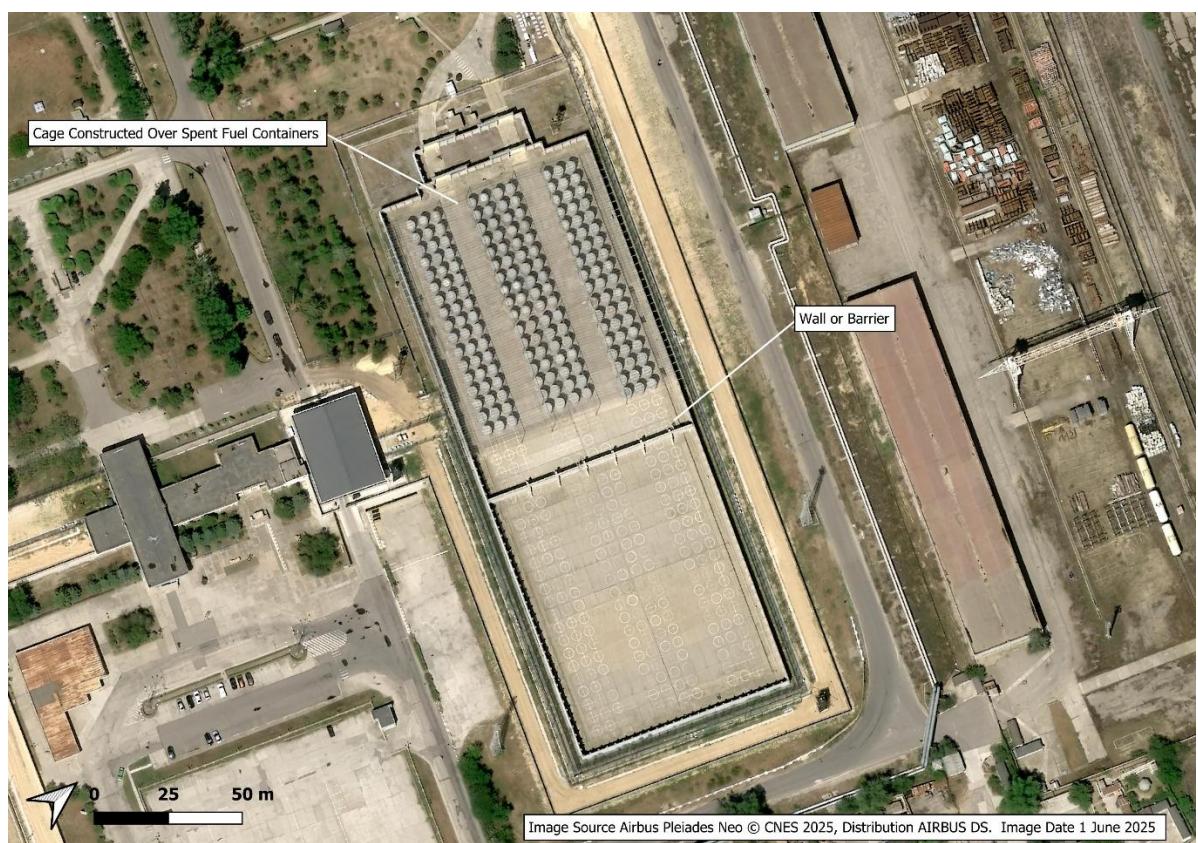
Fig. 17 – Spent Fuel Storage Area

Analyst Assessment: The construction of the wire mesh, building of sangars and other 'security' related constructions are likely to be part of the disinformation campaign designed to portray ZNPP as under threat from attack whereas it is almost certain that Ukraine will not conduct any operations against Russian Forces or the infrastructure at ZNPP which may compromise nuclear safety. **Assessment Ends.**

The installing of a wire mesh cage over the dry cask spent fuel storage compound is likely a measure to protect against drone strikes. Russia has previously claimed that the plant has been subjected to drone attack, providing evidence of small airframes and minor damage to plant infrastructure. Previous MIS reporting (Analysis of alleged unmanned aerial vehicle attacks against ZNPP dated 12 April 2024) challenged the Russian narrative in this respect, highlighting the lack of any benefit to the Ukrainians in attacking the plant. It was assessed that the likely scenario was a false flag operation on behalf of the Russians to discredit
