# THE IMPACT

of the Russian Drone Attack  
on the Chernobyl New Safe Confinement

Eric Schmieman

# Initial Assessment of the Impact of the Russian Drone Attack on the Chornobyl New Safe Confinement

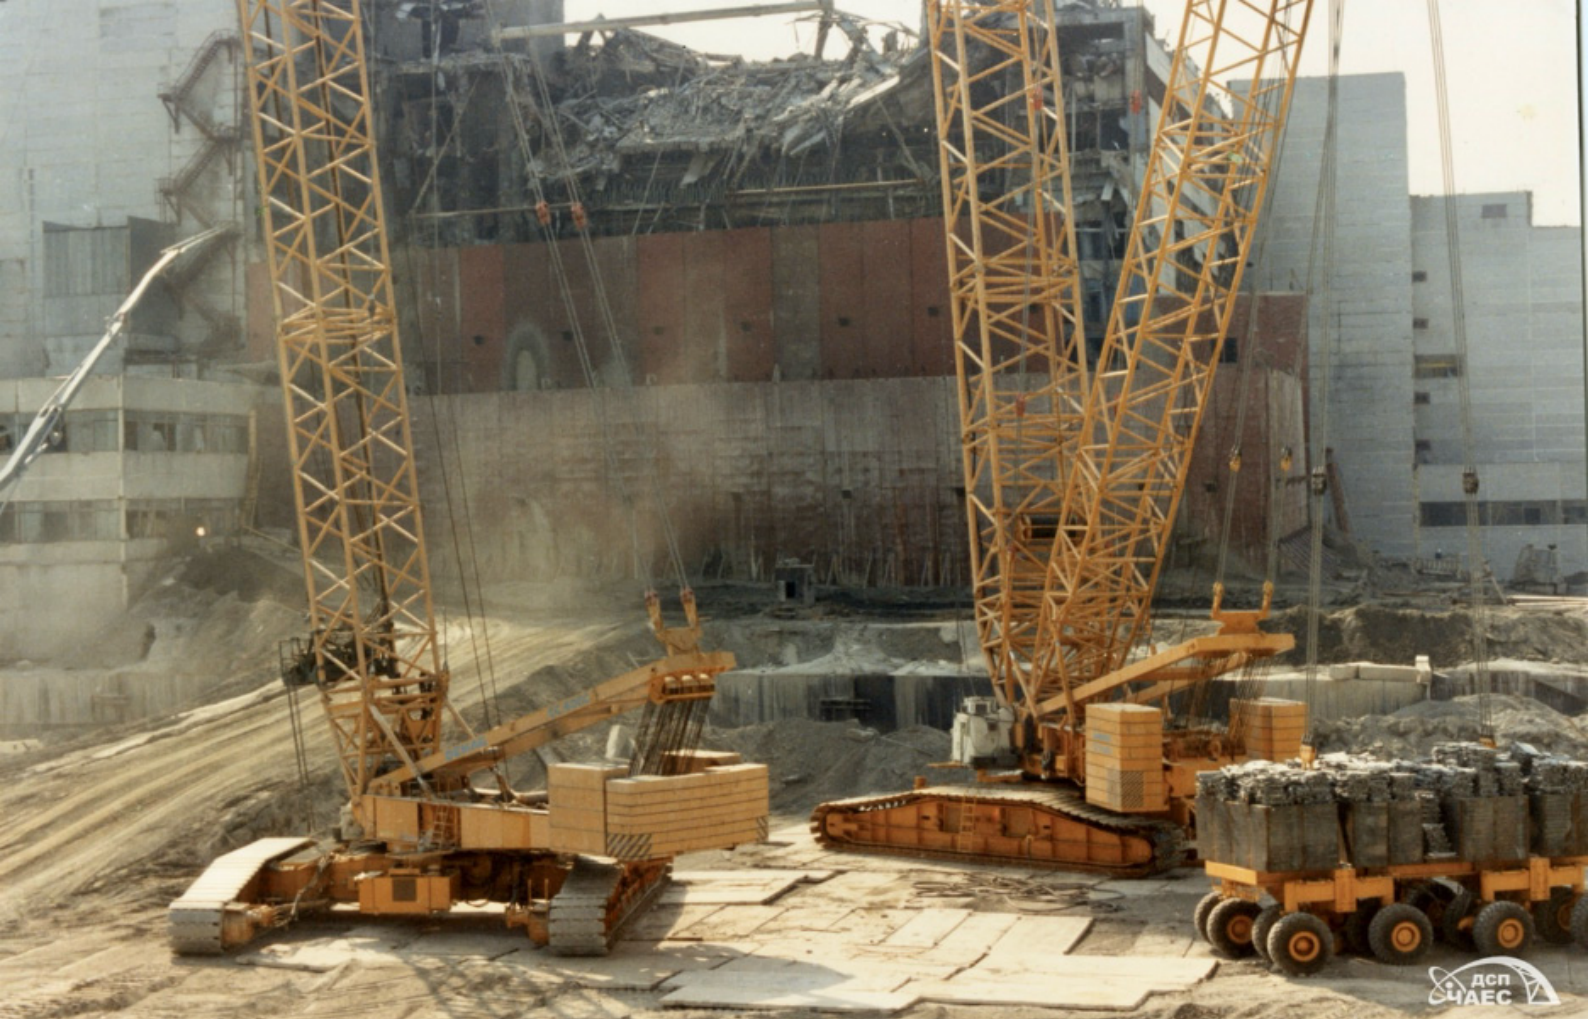
Demag cranes during construction of shelter in 1986 – Credit ChNPP

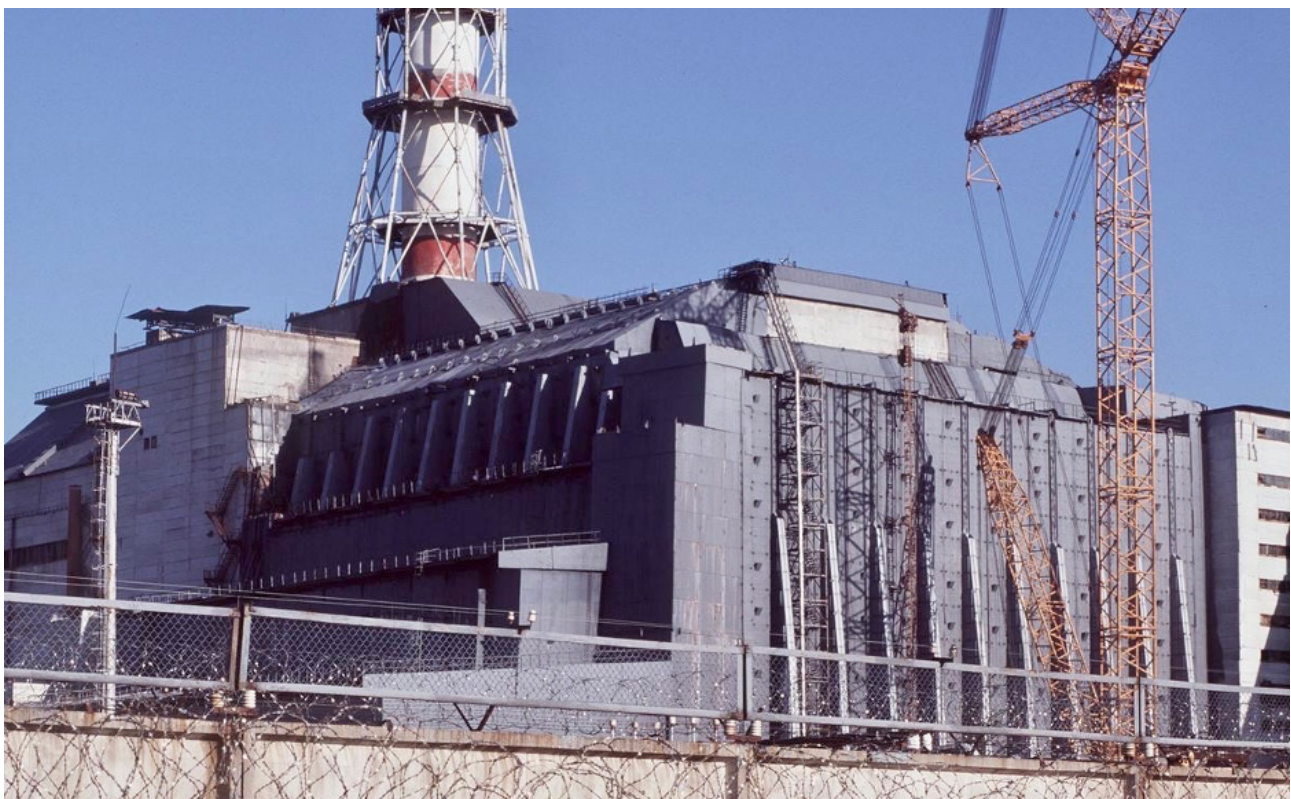
Shelter Object/Sarcophagus at Chernobyl unit 4, 1996 Credit Clive Shirley/Greenpeace

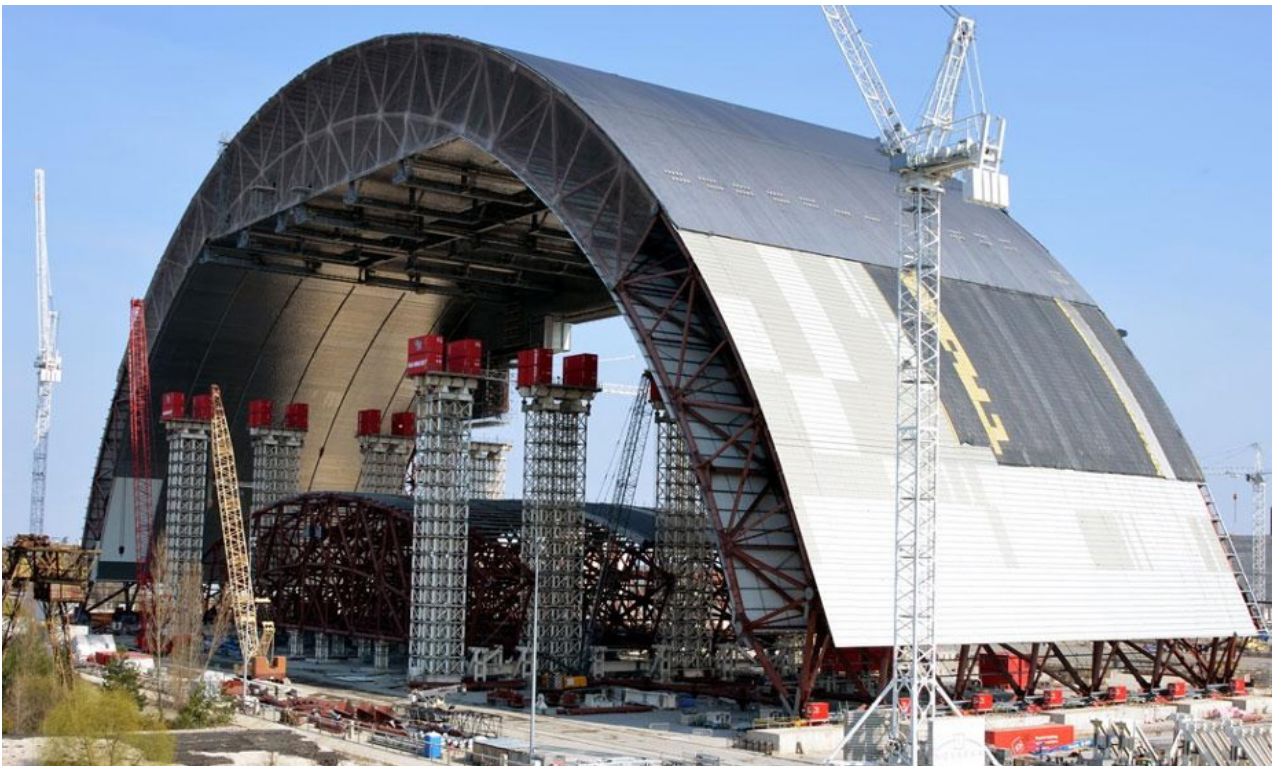
NSC structural members and inner/outer shells during construction - Credit EBRD

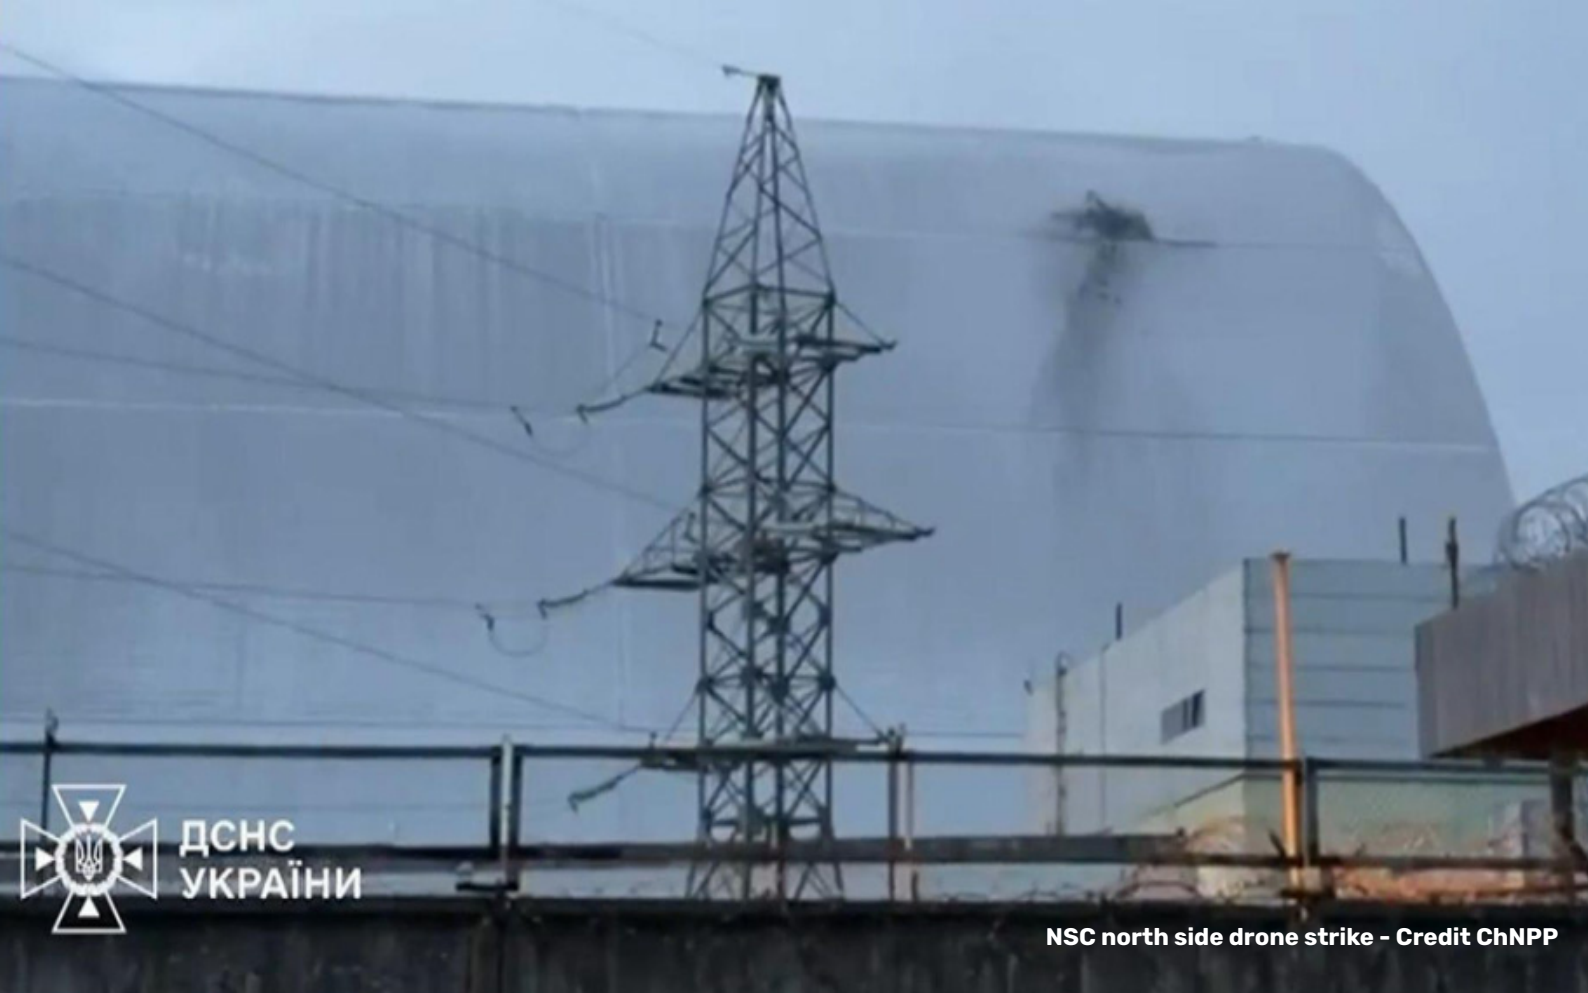
NSC north side drone strike - Credit ChNPP

The impact of the drone and subsequent explosion at an elevation of approximately 85 metres above the NSC floor caused an opening of approximately 15 m<sup>2</sup> through both the outside and inside arch shells.

The explosion also caused damage to bolted connections of the arch structural elements and deformed structural joints on the upper part of the Main Crane System Maintenance Garage<sup>43</sup>. Shrapnel from the explosion caused numerous smaller penetrations of the arch shells distributed over an area of about 200 m<sup>2</sup>.

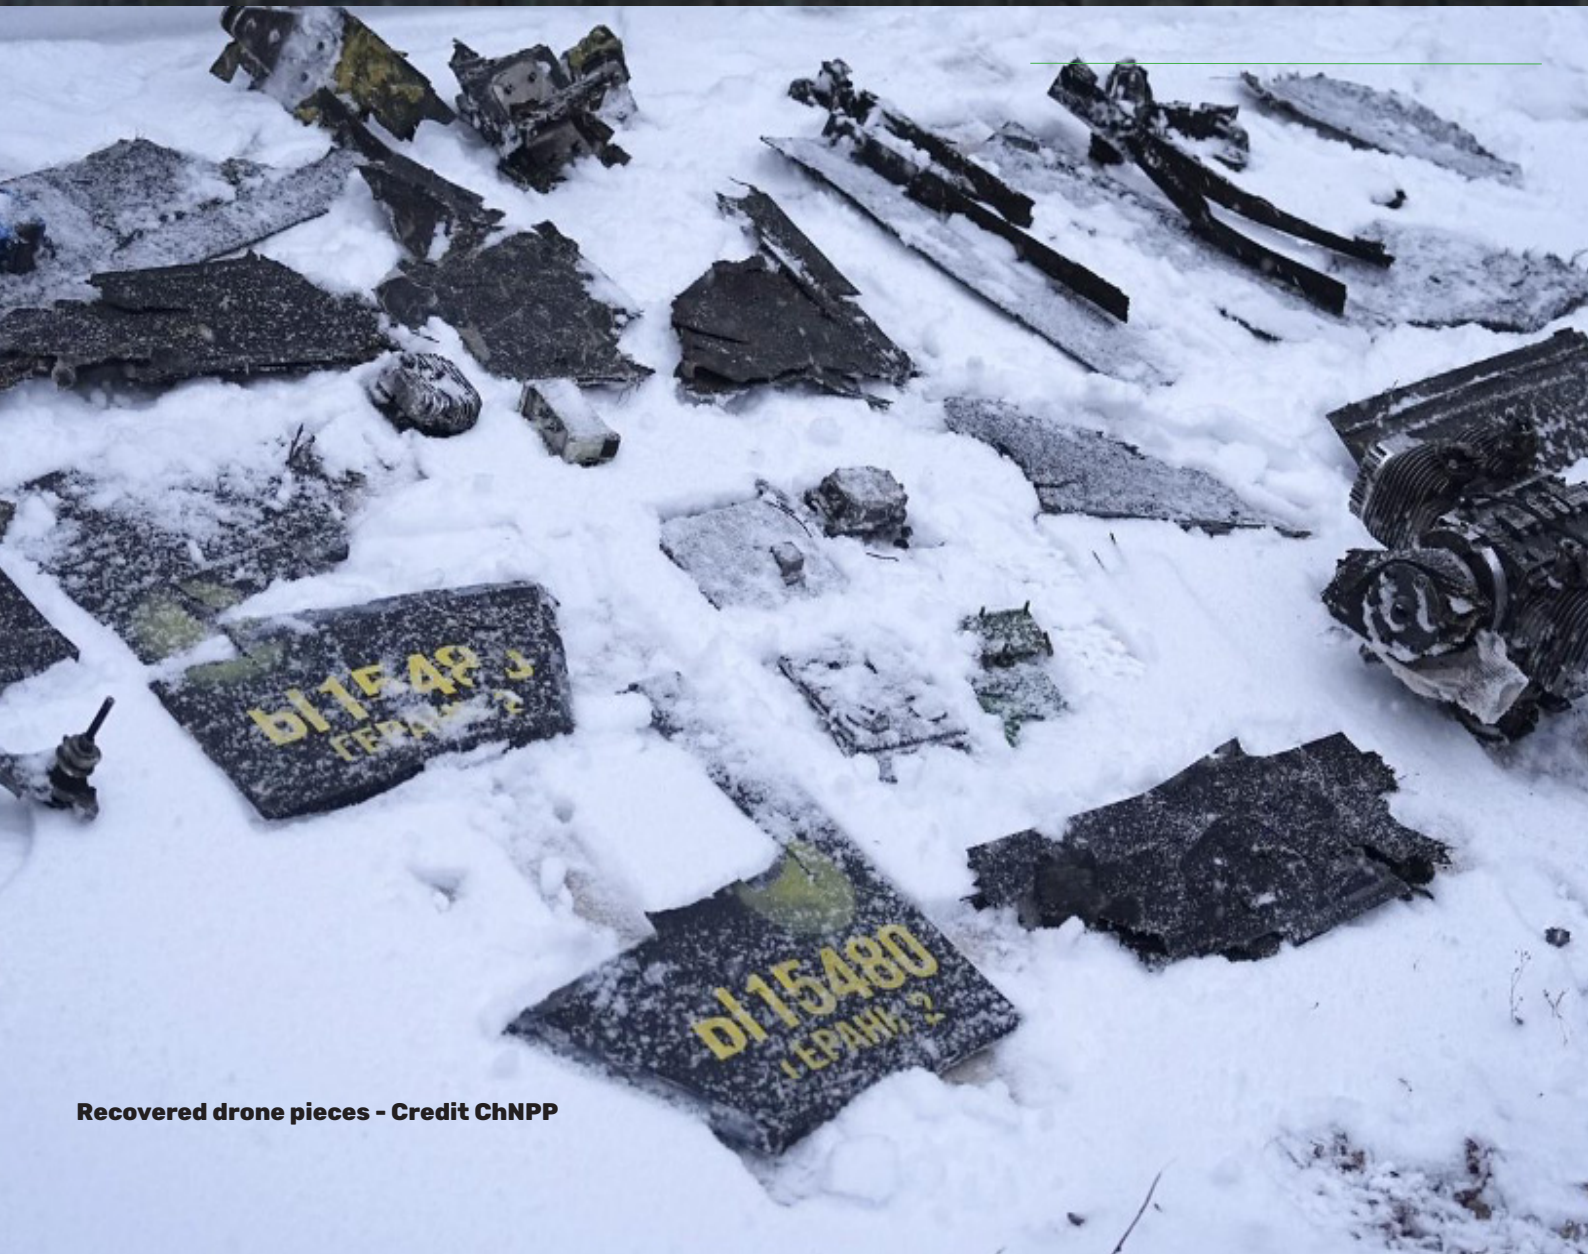
Recovered drone pieces - Credit ChNPP

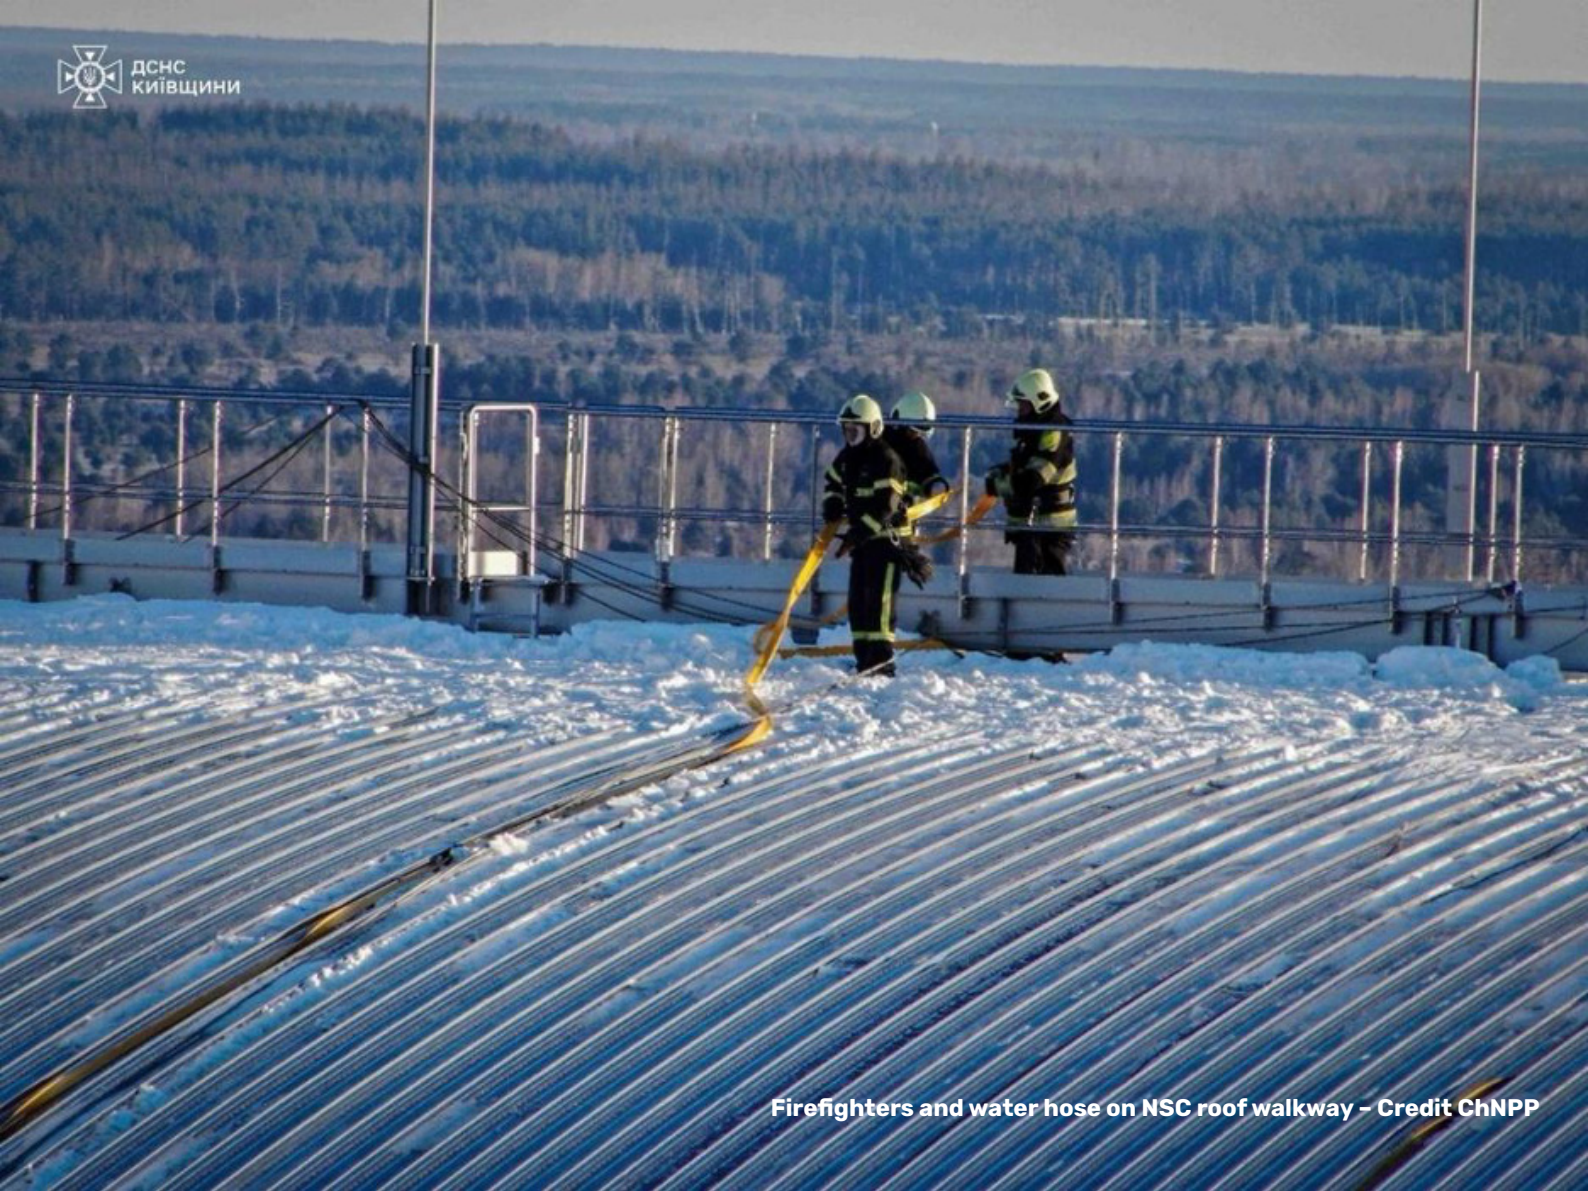
Firefighters and water hose on NSC roof walkway – Credit ChNPP

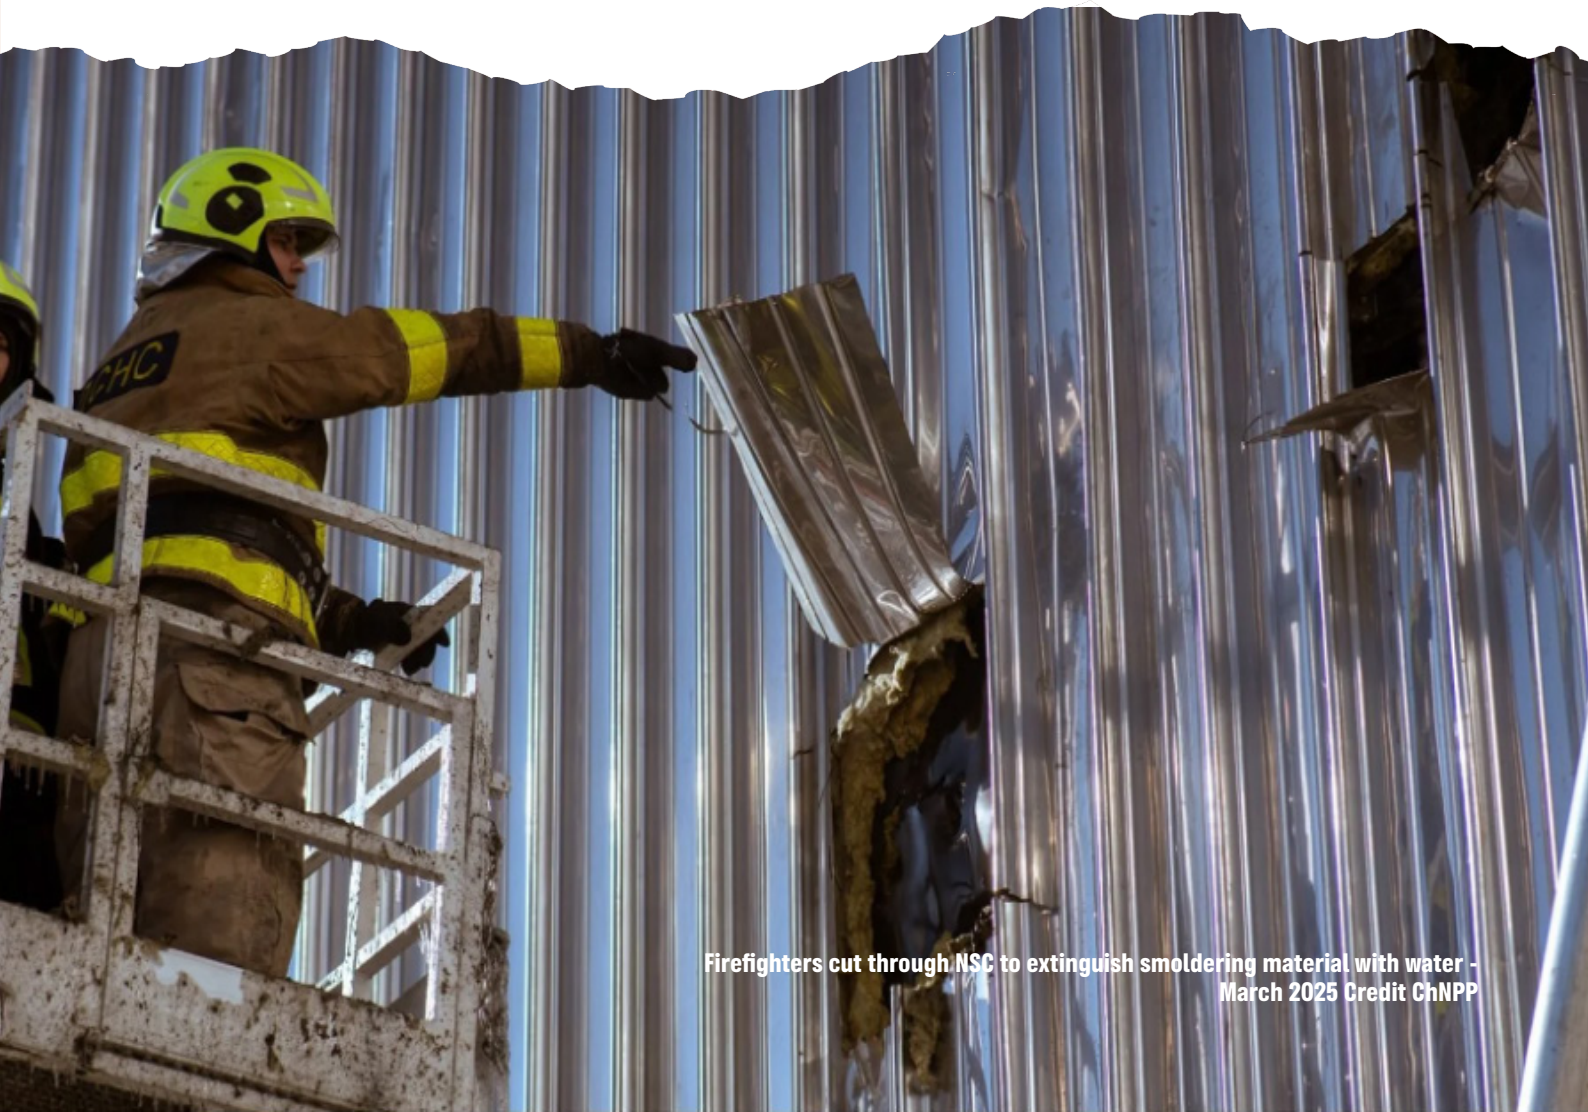
the smoldering EPDM membrane<sup>47</sup>. It has been estimated that 50% of the EPDM membrane on the north side of the NSC and 10% on the south side burned. The total amount of water injected and degree of damage to insulation is unknown at this time<sup>48</sup>. Some of the water injected into the outer shell quickly drained out and some continued to drip

Firefighters cut through NSC to extinguish smoldering material with water - March 2025 Credit ChNPP
