**Analysis of Russian Military Activity at the
Zaporizhzhia Nuclear Power plant (ZNPP)
During June & August 2025**

December 2025

Proprietary:
Forbes McKenzie
McKenzie Intelligence Services
forbes@mckenzieintelligence.com
Commissioned by Greenpeace Ukraine

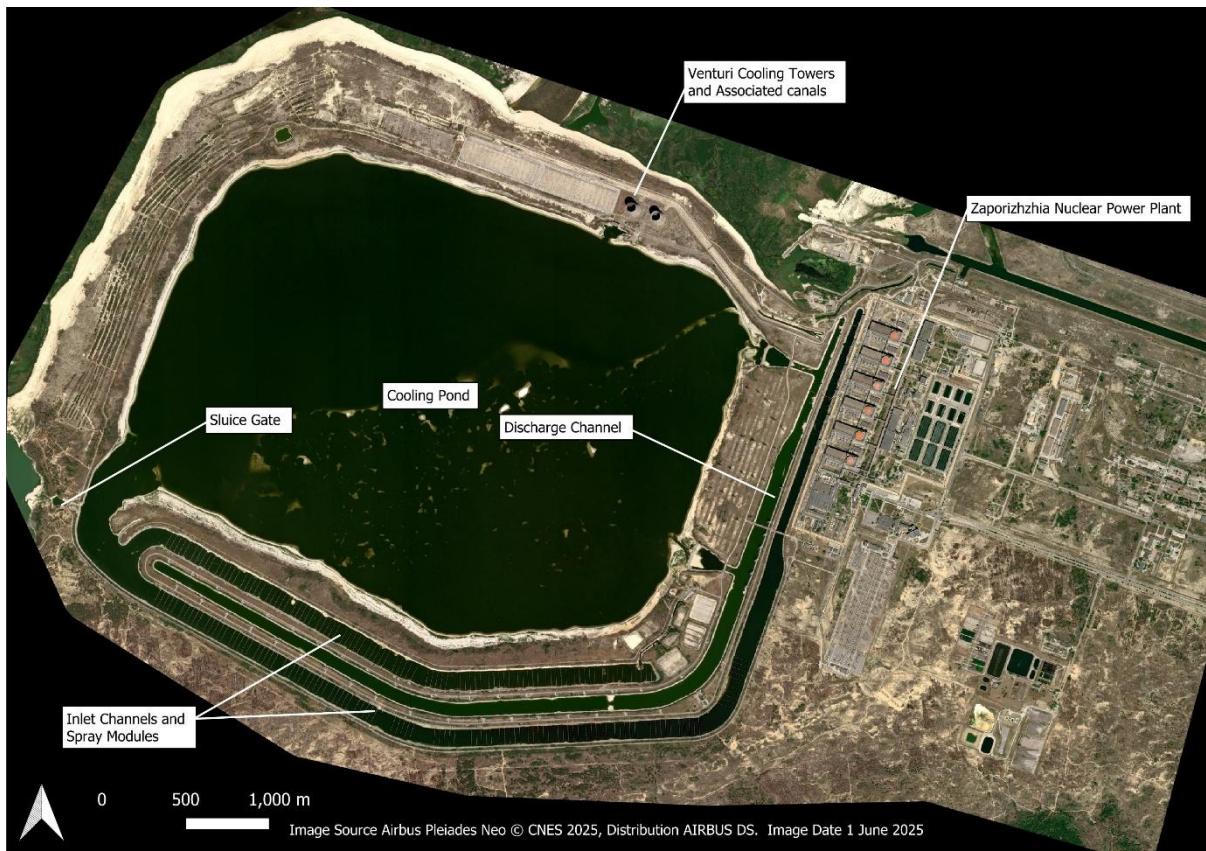
Fig.1 – ZNPP Installation Overview

The Zaporizhzhia Nuclear Power Plant is located on the southern bank of the Dnipro River in southern Ukraine (Fig. 1), part of the industrial town of Enerhodar and close to the town of Vodyanoye. The plant is approximately 440km southeast of Kyiv and 160km north of the Crimean peninsula. The plant consists of six reactor and turbine halls which connect by way of pylons to an associated transformer yard which, prior to the invasion, was connected to ten transmission lines to the Ukrainian national grid. To the immediate west of the plant there is a large cooling pond and associated infrastructure, including spray modules and venturi cooling towers.

The plant is situated both within and outside of a secure, multi-layered perimeter. Within the perimeter are the reactor and turbine halls, an array of 12 spray ponds for cooling, likely auxiliary power generators and other essential industrial, operational and administrative facilities. External to the perimeter, a large cooling pond and network of canals have been constructed with the intention of providing the plant with water with which to cool the reactors. The transformer yard is also external to the secure perimeter.

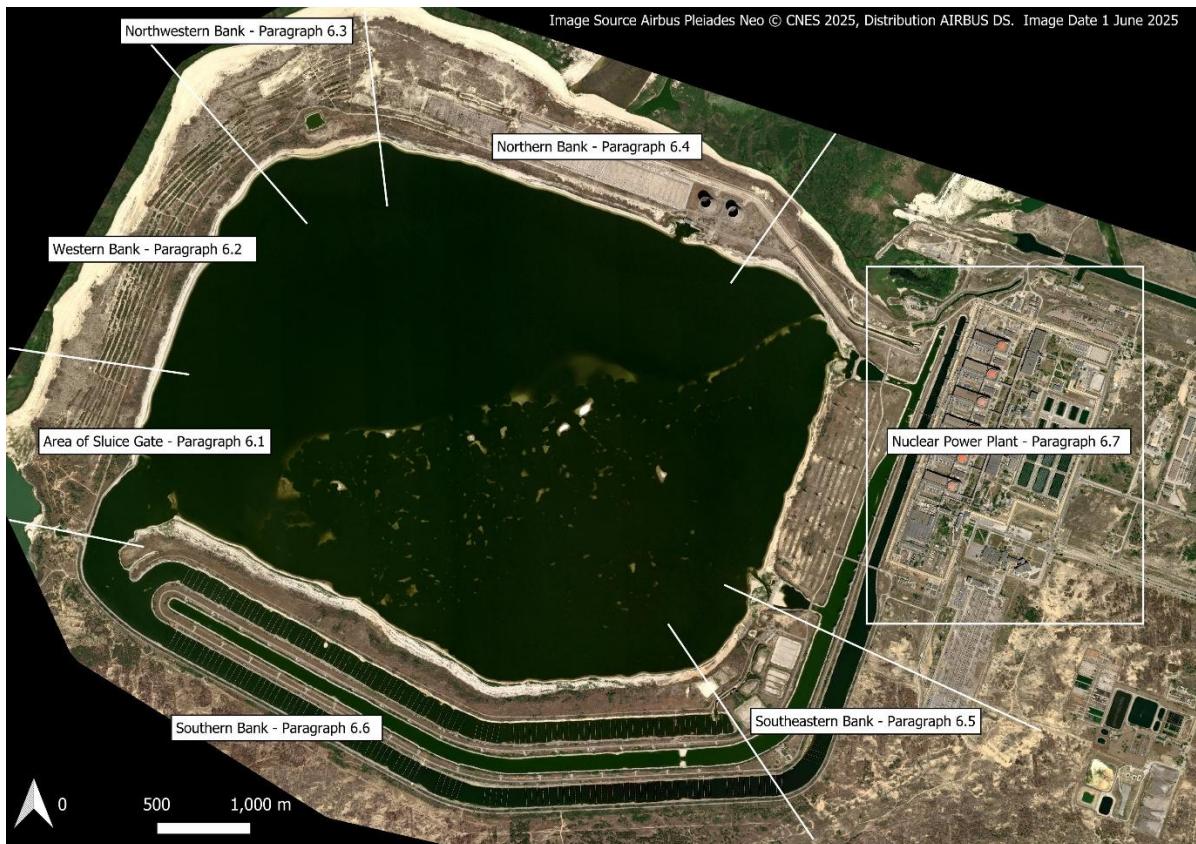
Fig.5 – Reporting Zones for ZNPP

Various areas of military and other significant activity were observed at ZNPP and on the banks around the cooling pond throughout the reporting period. For reporting purposes, these zones are broken down as follows and illustrated at Fig.5:

- Area of Sluice gate – Paragraph 6.1
- Western Bank – Paragraph 6.2
- Northwestern Bank – Paragraph 6.3
- Northern Bank – Paragraph 6.4
- Southeastern bank – Paragraph 6.5
- Southern Bank – Paragraph 6.6
- Nuclear Power Plant – Paragraph 6.7
