LESSONS NOT LEARNED FROM THE FUKUSHIMA ACCIDENT

Risks of the European NPPs 10 years later

Study commissioned by Greenpeace

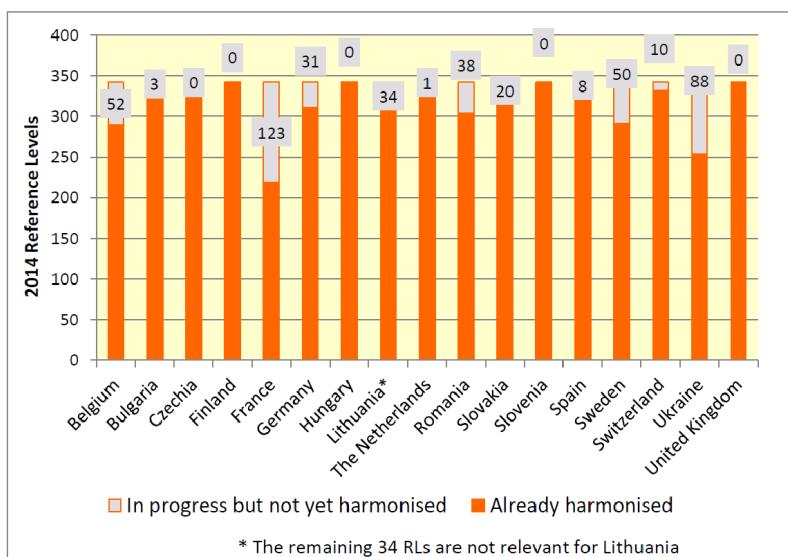
Figure 1: Reported status of implementation of 2014 RL in 2020 (WENRA RHWG 2020a)

WENRA RHWG (2020a) reports on the implementation of the revised RLs in the national regulatory frameworks of WENRA countries.

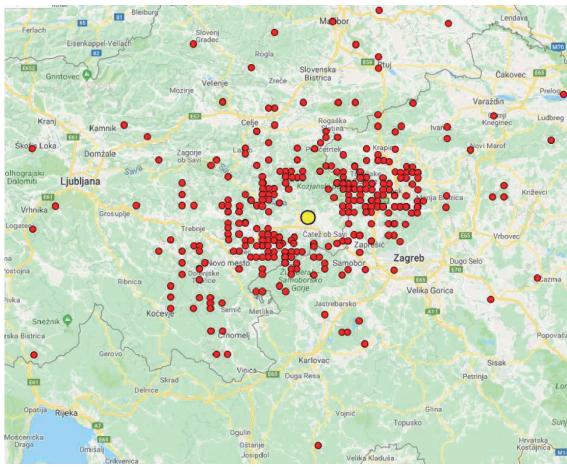
Figure 2: Maximum distances for necessary evacuation after a severe accident at the Krško NPP (JOE 2019)

On the Croatian side an Urgent Protective Action Zone (UPZ) is set up to the distance of 20 km from the NPP Krško. This is the zone where evacuation plans should be set up. The analysis shows that the current UPZ covers only about 30% of cases where evacuation is needed. Evacuations of the population should be undertaken before the arrival of the cloud to protect from cloud-shine, from inhalation during the passage of radioactive cloud and from ground-shine. (JOE 2019)

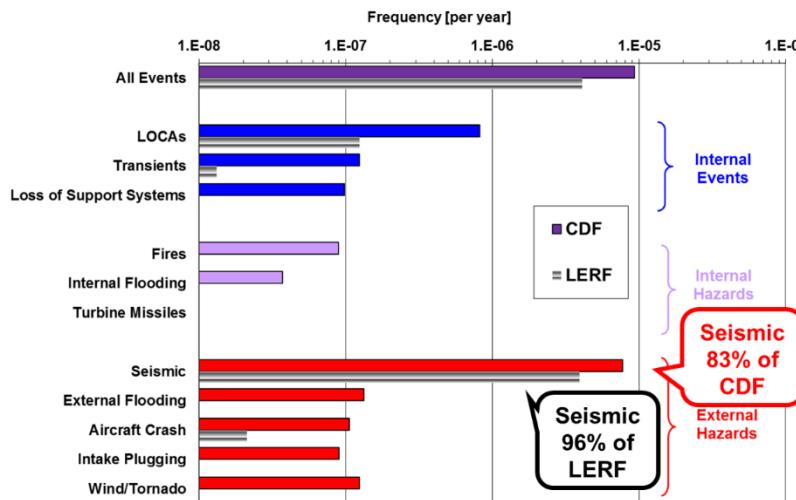
Figure 3: Core damage frequency (CDF) und Large early releases frequency (LERF) at Beznau NPP (Status 2015) (RICHNER 2015)

It is noteworthy that an earthquake contributes 83% to the CDF and 96% to the frequency of a large and early release. Should an earthquake trigger a core melt accident, it will result in high and early releases in almost all cases. This means that the releases are so large that the population would have to be evacuated, but there is not enough time to do so.
