# LESSONS NOT LEARNED FROM THE FUKUSHIMA ACCIDENT

**Risks of the European NPPs 10 years later**

Hannover, February 2021

**Study commissioned by Greenpeace**

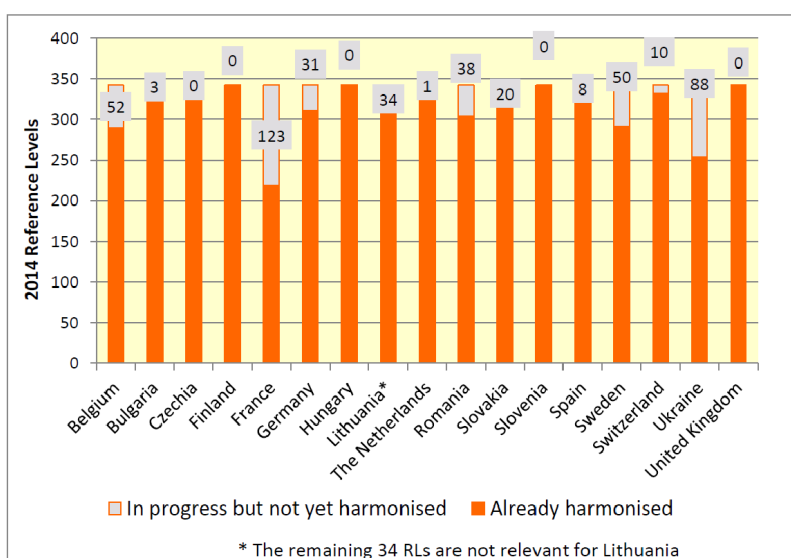
Figure 1: Reported status of implementation of 2014 RL in 2020 (WENRA RHWG 2020a)

WENRA RHWG (2020a) reports on the implementation of the revised RLs in the national regulatory frameworks of WENRA countries.

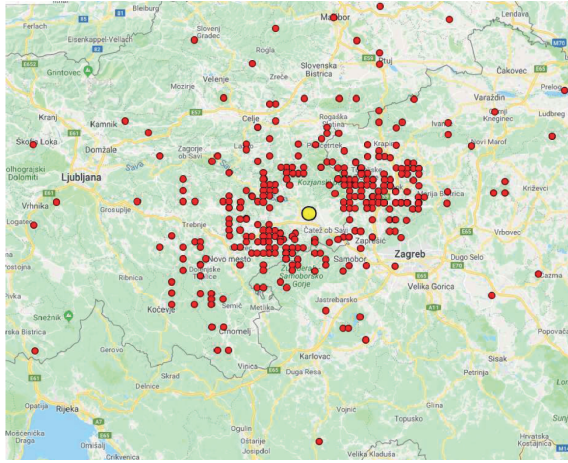
Figure 2: Maximum distances for necessary evacuation after a severe accident at the Krško NPP (JOE 2019)

On the Croatian side an Urgent Protective Action Zone (UPZ) is set up to the distance of 20 km from the NPP Krško. This is the zone where evacuation plans should be set up. The analysis shows that the current UPZ covers only about 30% of cases where evacuation is needed. Evacuations of the population should be undertaken before the arrival of the cloud to protect from cloud-shine, from inhalation during the passage of radioactive cloud and from ground-shine. (JOE 2019)

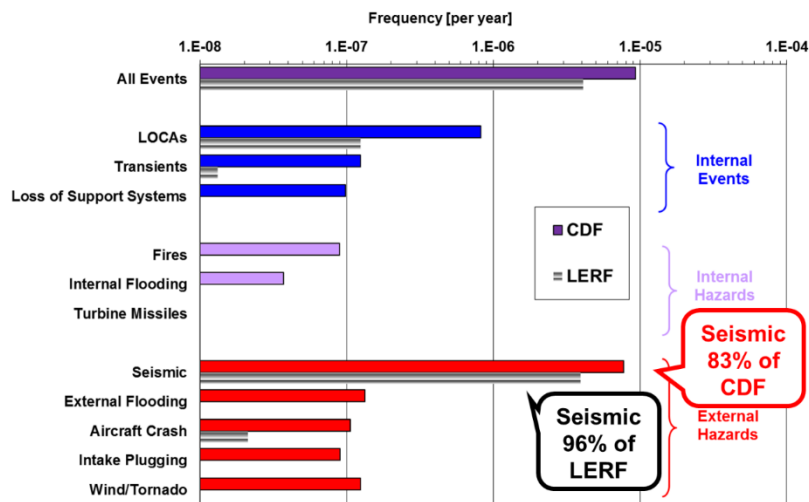
Figure 3: Core damage frequency (CDF) und Large early releases frequency (LERF) at Beznau NPP (Status 2015) (RICHTER 2015)
